**SewerVUE Pipe Penetrating Radar Case Study
Sanitary Sewer Pipe Inspection
Harvard Gulch Interceptor
MWRD Denver, CO**

SUMMARY

Pipe penetrating radar (PPR), a new pipe inspection technology was used for condition assessment in a 27 inch interceptor in Denver, CO. Metro Wastewater Reclamation District (MWRD), the owner of the interceptor had limited information about the condition of the pipe, so they contacted SewerVUE in order to undertake a multisensory pipe condition assessment that included CCTV, PPR and laser profiling.

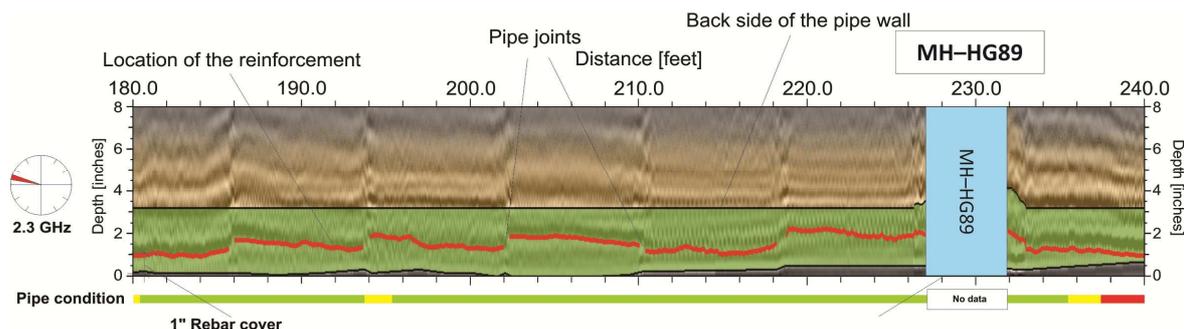
Figure 3. A typical PPR profile. The clock position and the frequency of the antenna are shown on the left side of the profile. The red color on pipe condition marker indicates an area where immediate attention is recommended.

PPR data showed variations in pipe wall thickness, as well as location, depth and spacing of rebar. Pipe wall thickness appeared to be uniform with no significant pipe wall loss. The remaining pipe-wall thickness was between 2.5 - 3.3". The measured minimum pipe wall thickness was 2.5". Rebar cover, while showing variations along the surveyed clock positions appeared to be in the 0.25" and 3.2" range. Where rebar cover appeared to be less than 0.73" it was mostly due to the pipe manufacturing process and not the result of pipe wall loss. No significant voids were detected along the inspected line.

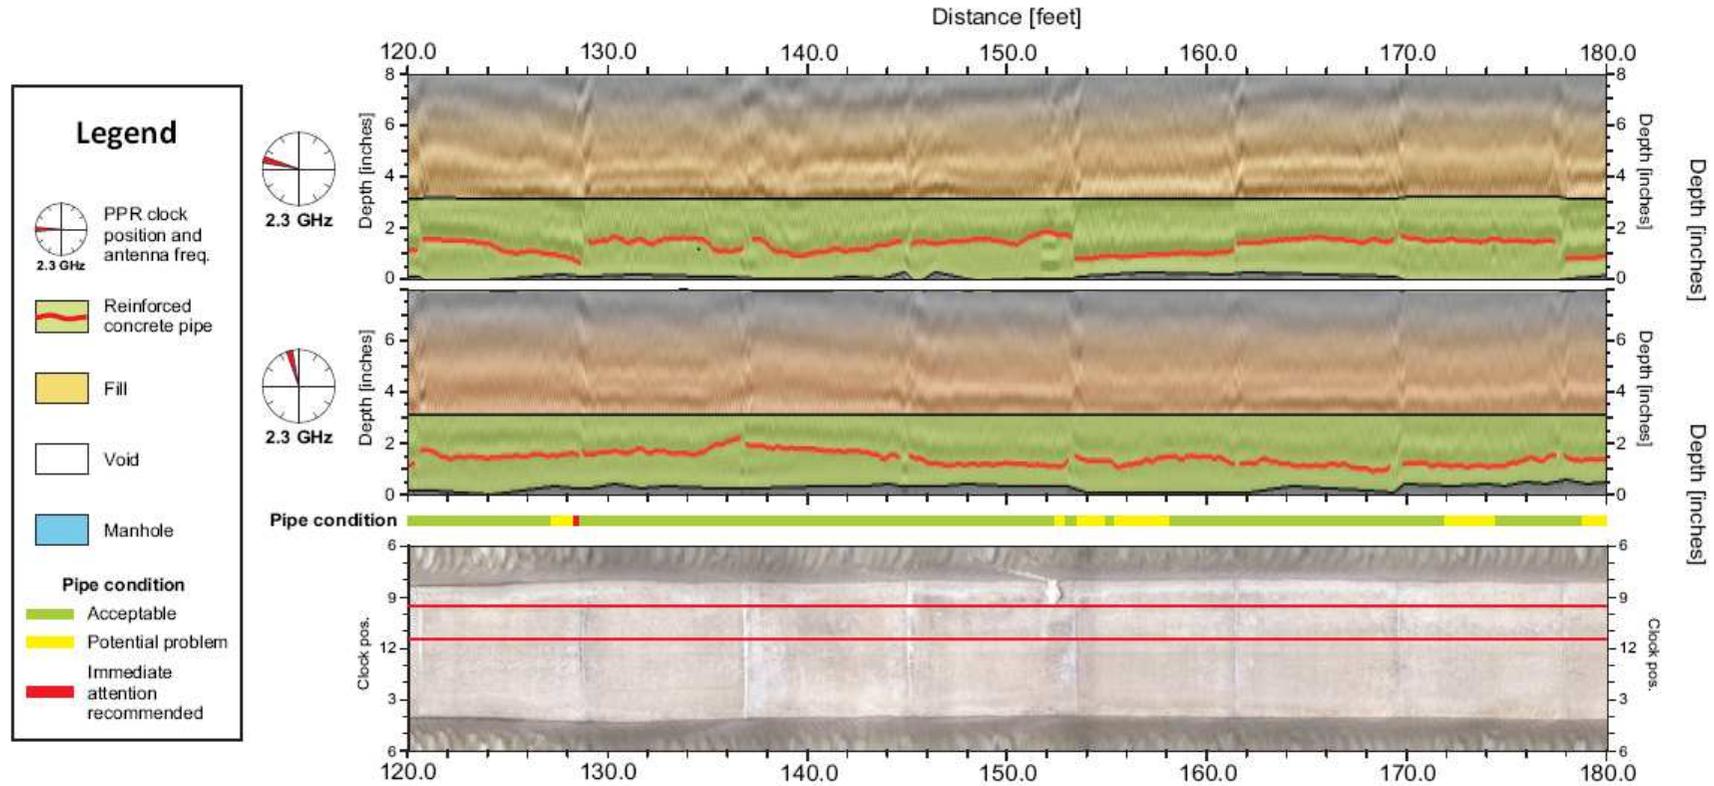
Figure 4. PPR results: the interpreted PPR profiles are correlated with the CCTV foldout view. Pipe condition is indicated by a three color marker below the PPR profiles: green: acceptable, yellow: areas with potential problem, red: immediate attention is recommended.

clock positions on the vertical axis. Anomalies and other notable features are color coded. Pipe wall thickness is marked by a continuous black line, reinforcement is marked by red dots which are then connected by a red line. The CCTV data did not show significant pipe degradation.

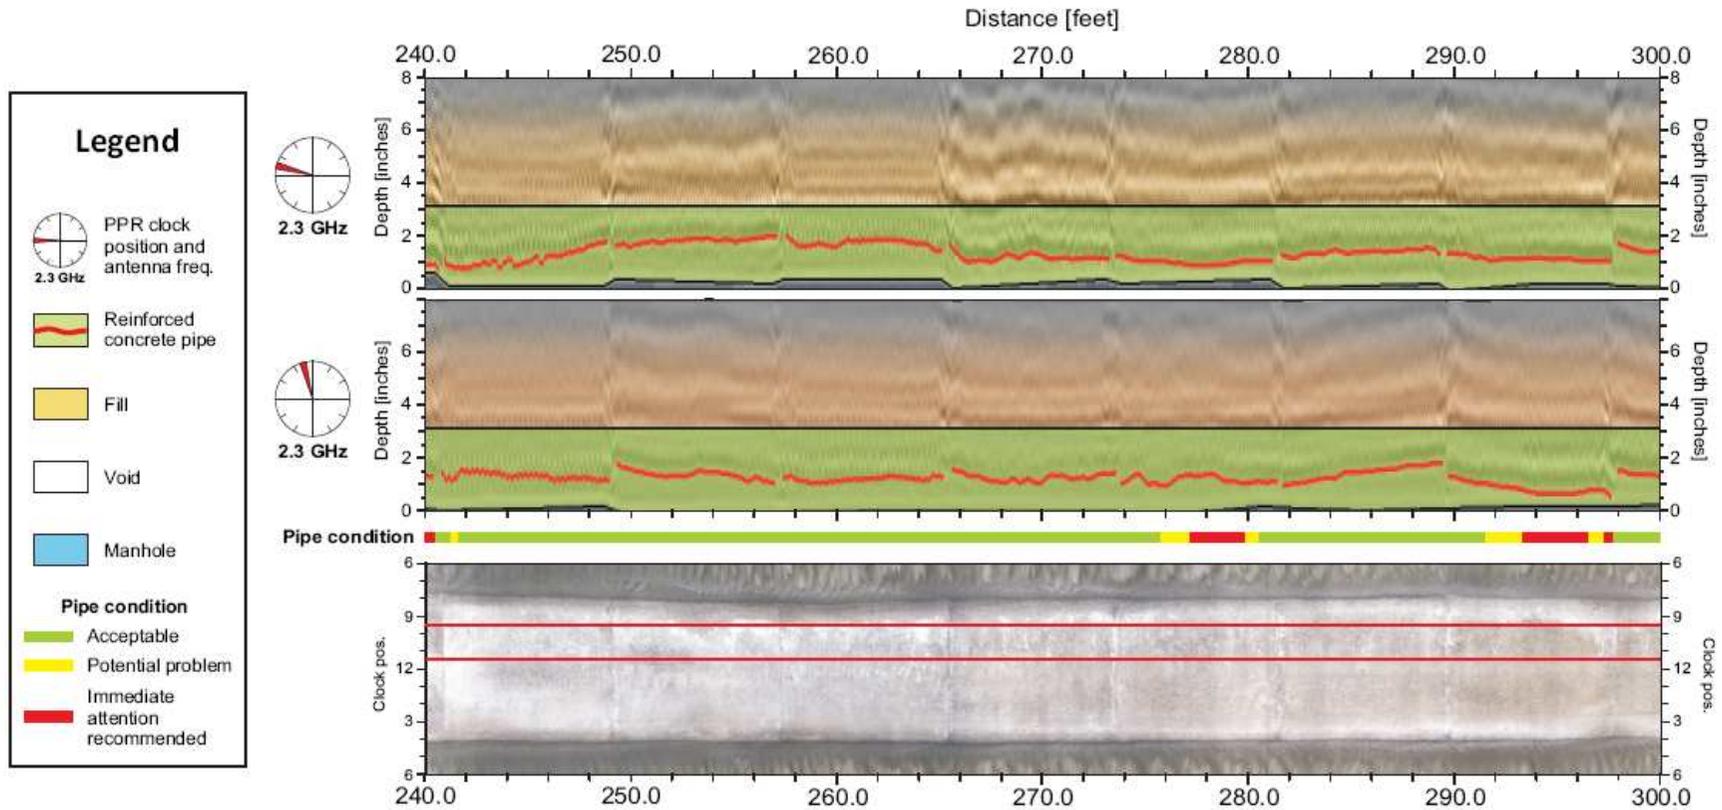
Figure 5. PPR results: the interpreted PPR profiles are correlated with the CCTV foldout view. Pipe condition is indicated by a three color marker below the PPR profiles: green: acceptable, yellow: areas with potential problem, red: immediate attention is recommended.

The PPR results clearly showed areas where the rebar cover was less than 0.53", the recommended minimum by ASTM standards. The SewerVUE Surveyor's LIDAR data (Figure 6) is correlated with an onboard inertial navigation system (INS) to continuously calculate the

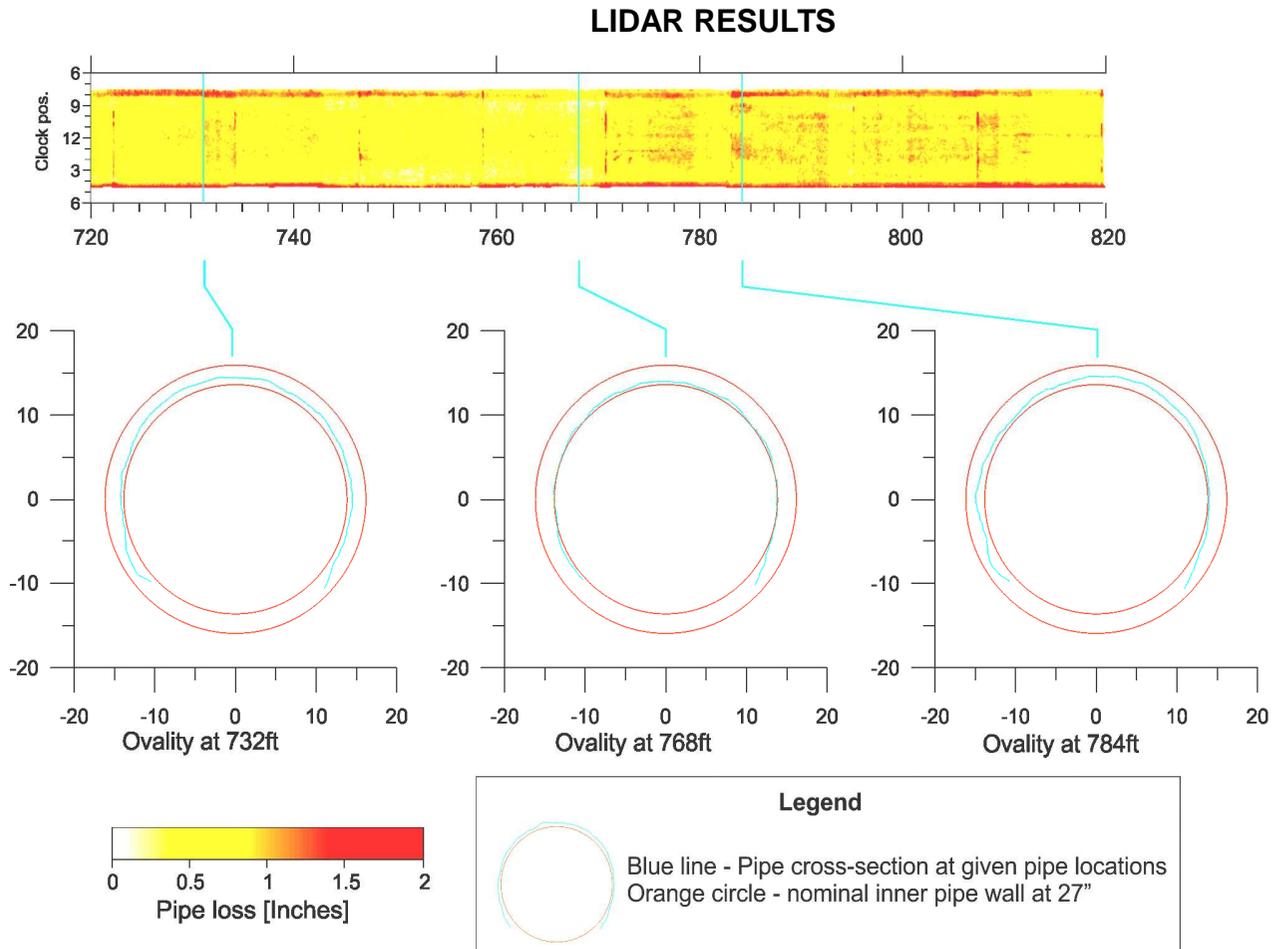
position, orientation, and velocity (direction and speed of movement) of the robot without the need for external references. Both the foldout and the cross-sections show significant erosion at the current flow level at the 7:30 and 4:30 clock positions.

Figure 6. LIDAR results: Both the foldout and the cross-sections show significant erosion at the current flow level at the 7:30 and 4:30 clock positions.
