**Sanitary Sewer Pipe Inspection  
Pipe Penetrating Radar  
Salmon Creek and St John's Trunks  
Vancouver, WA**

September, 2012

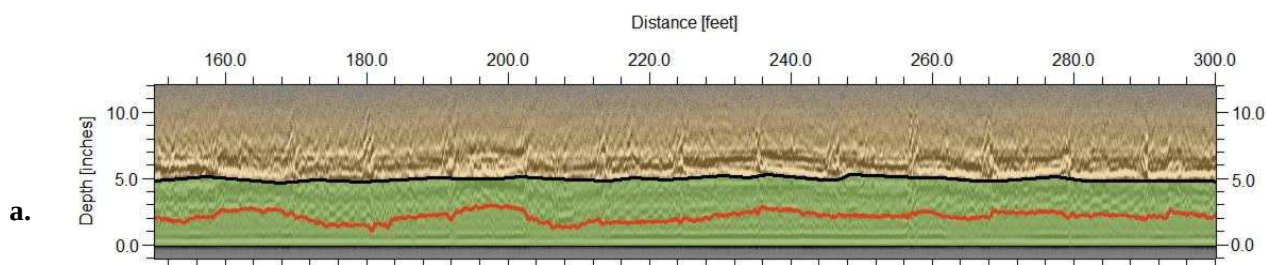
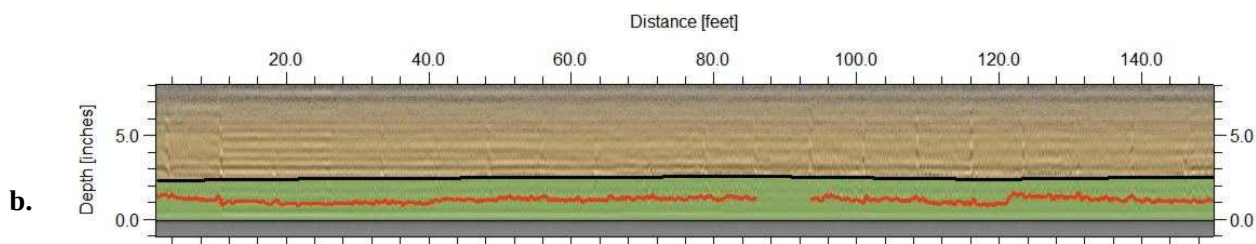
**Figure 3.** PPR inspection results showing wall thickness and rebar depth superimposed on the processed radar sections. Pipe wall thickness is marked by continuous black line, rebar shown as red lines (a. St Johns Trunk; b. Salmon Creek Avenue Trunk).

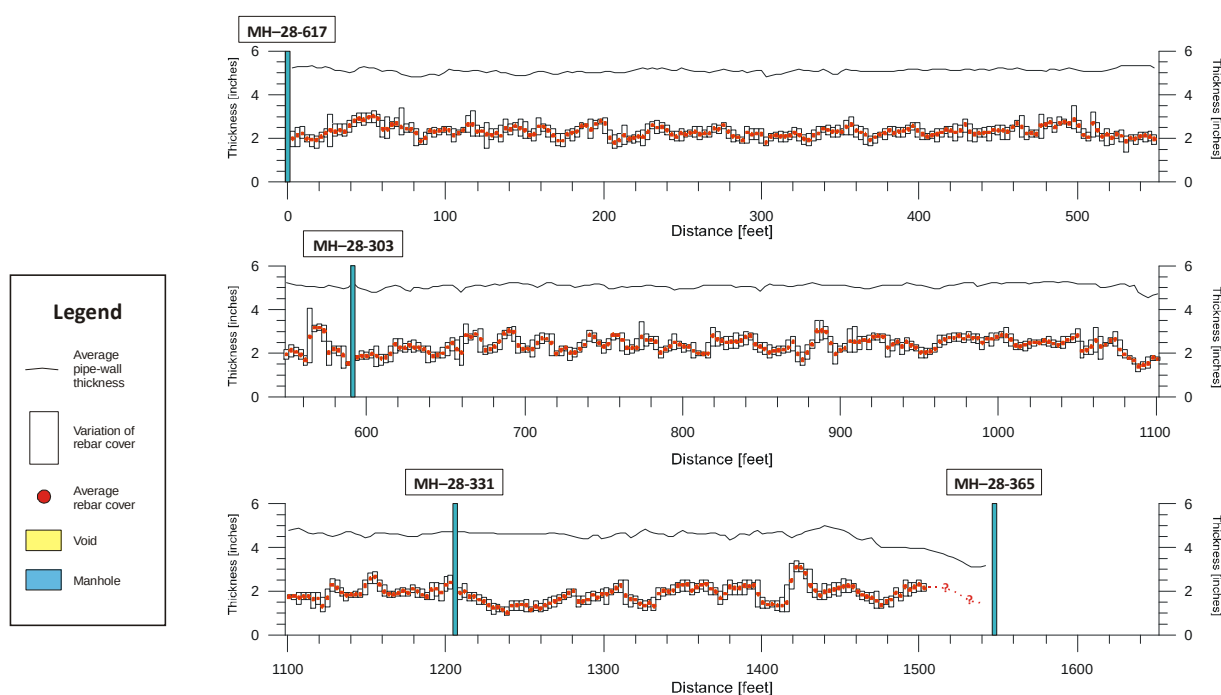
**Figure 4.** Summarized PPR results for St Johns Trunk. Pipe wall thickness is represented by a continuous black line. Change in rebar cover is represented by bar graphs showing rebar cover variations (min-max) for every 3 ft interval. Red dots mark average rebar cover for the same 3 ft interval.

The PPR data indicate variations in pipe wall thickness, as well as location, depth and spacing of rebar. The results show that pipe wall thickness is around 5 and 5.25 inches, between 0 and 1085 ft. It is between 5 and 4.5 inches between 1085 and 1460 ft, and between 4.5 and 3.75 inches between 1460 ft and 1545 ft at the upstream manhole MH 28-377 where corrosion appears most severe.

Rebar cover varies between 1 and 4 inch. Rebar signal is weak between 1475 and 1505 feet and very weak or appears to be absent between 1505 and 1545 feet. A minor void was detected at 27.5 ft at 10 o'clock position. This void is approximately 4 feet long and 4 inches high.

Overall, the majority of the 36-inch trunk line is structurally in fair to poor condition. Inspection of the upstream-most pipe segment revealed evidence of severe corrosion. The PPR data indicated less concrete rebar cover at the upstream section of the trunk line and a loss of wall thickness as the robot moved upstream. Assuming the initial pipe design considered the railroad loading and appropriate dead loads, the loss of wall thickness and suspected corrosion in the reinforcement indicates that the existing pipe may be compromised structurally.

The use of PPR combined with man-entry coring and visual CCTV data provided the necessary information for the District to understand the condition of these critical trunk lines. For the St. Johns Trunk, the lack of rebar signal and the concrete material scraped off during the PPR inspections indicate poor structural condition. This condition can be addressed trenchlessly before further deterioration renders a trenchless solution infeasible. For the Salmon Creek Interceptor, knowing that the 21-inch portion does not contain reinforcement is important information. Follow-up man-entry inspections confirmed that the pipe is in poor to fair condition; rehabilitation, while not immediately urgent, should be planned for in the near future.

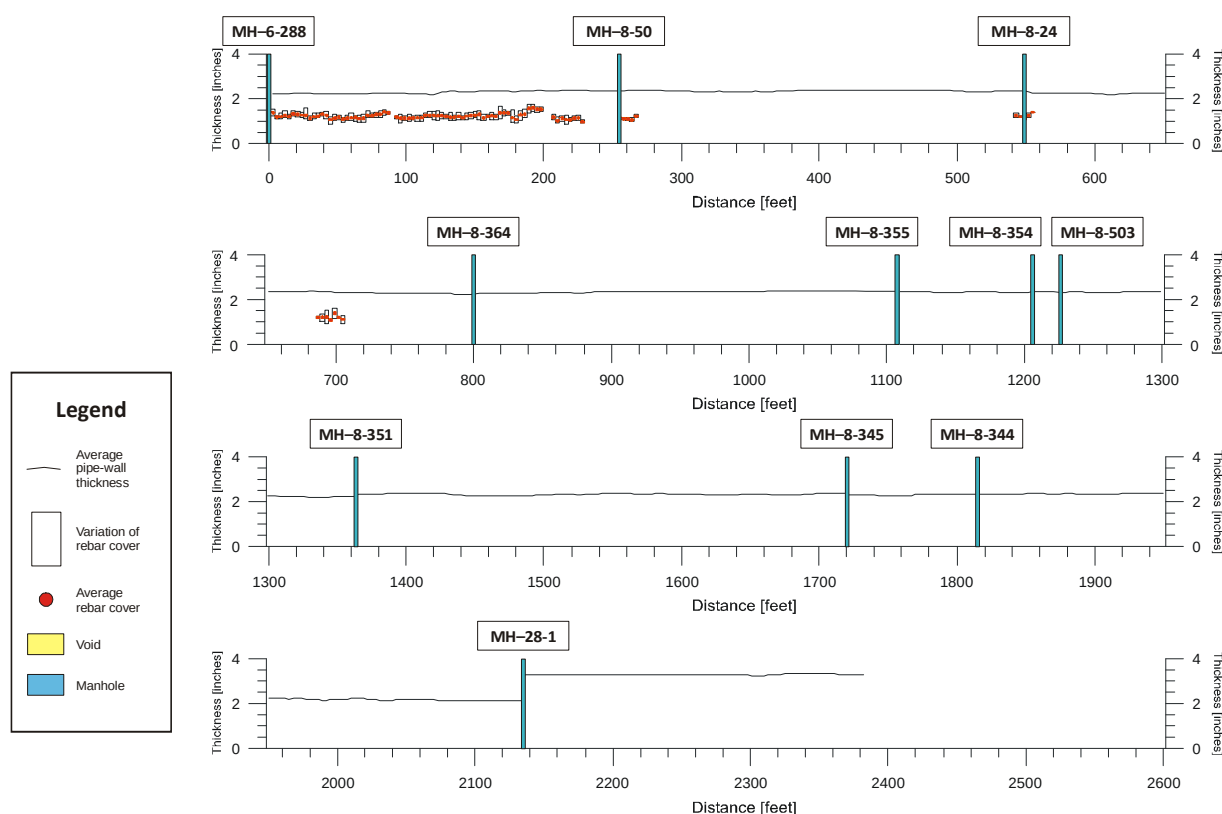
**Figure 5.** Summarized PPR results for Salmon Creek Avenue Trunk.

Pipe wall thickness is 3.25 inch with little variations. What is striking is the apparent lack of rebar. With the exception of 0 to 225 feet between MH 6-288 and MH 6-850 and 685 ft to 707 ft there appears to be no rebar reflection on the PPR profiles indicating that there is no rebar in the majority of the pipe. Where rebar is present it appears to be uniform with adequate cover and little variation in depth. PPR scanning did not detect any voids in the fill material around the pipe.

The majority of the 21-inch-diameter portion of the pipe revealed evidence of concrete corrosion. The interior cement layer had either corroded or eroded, resulting in projecting aggregate. The initial PPR results were recalibrated with data from a follow-up man-entry pipe wall thickness measurement.

The 24-inch segment that crosses underneath the Interstate 205 overpass revealed a uniform wall, a fairly smooth interior cement layer, and hardness commensurate with normal concrete. PPR also indicated that reinforcement is present in the pipe with adequate concrete cover. Overall, the 21-inch-diameter portion of the pipe is in poor structural condition and the 24-inch-diameter position of the pipe is in fair to good structural condition.

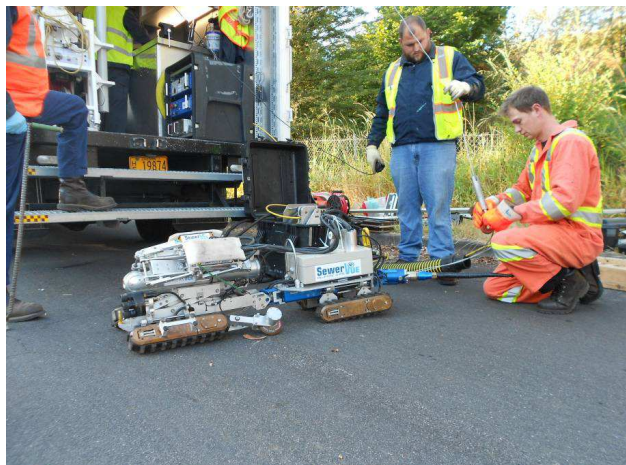
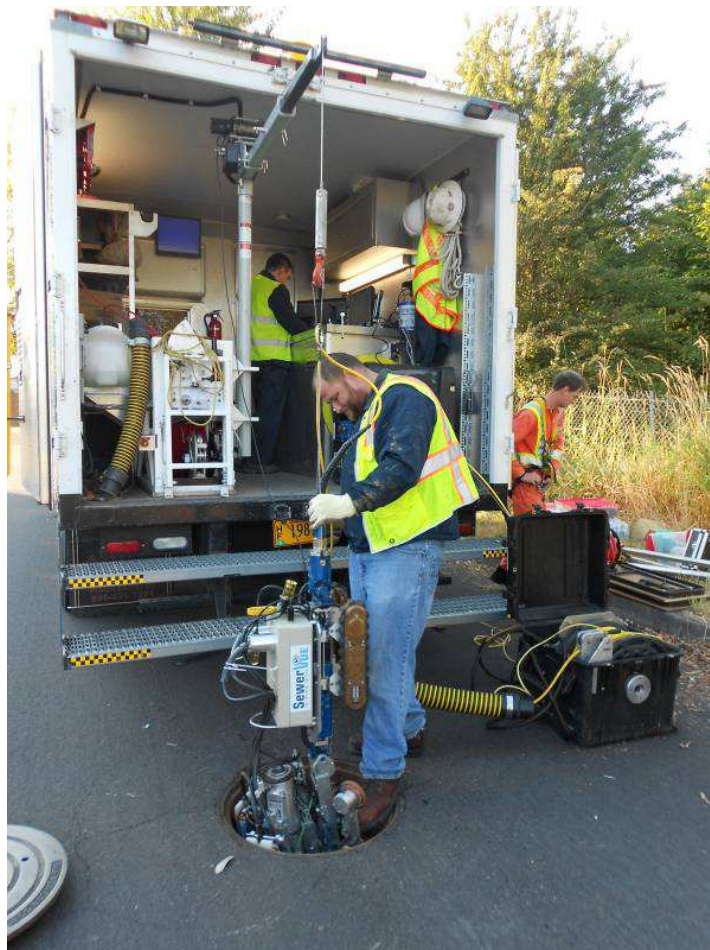
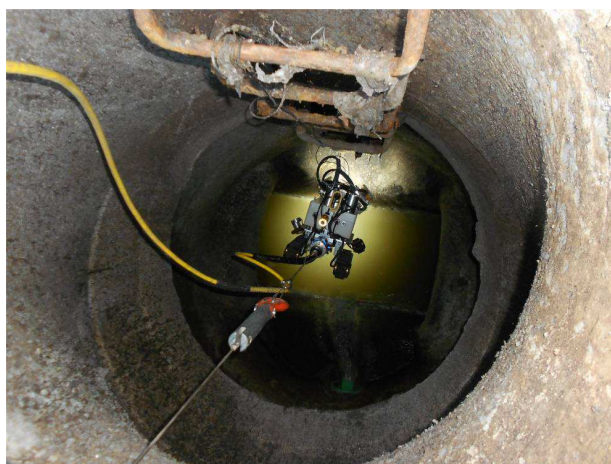
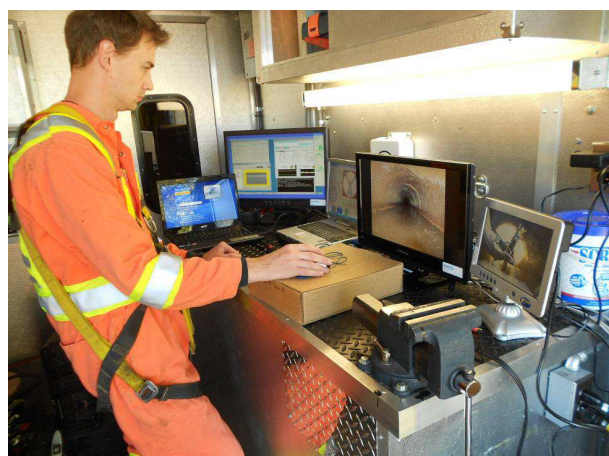
### St Johns Trunk MH 28-303

The CCTV results showed concrete surface spalling and buildup above the water level for the entire 1,549 LF of the 36-inch RCP and two locations with visible infiltration at joints. The graphed results show the summary results from the 10, 11, 1 and 2 o'clock positions (Figure 4).

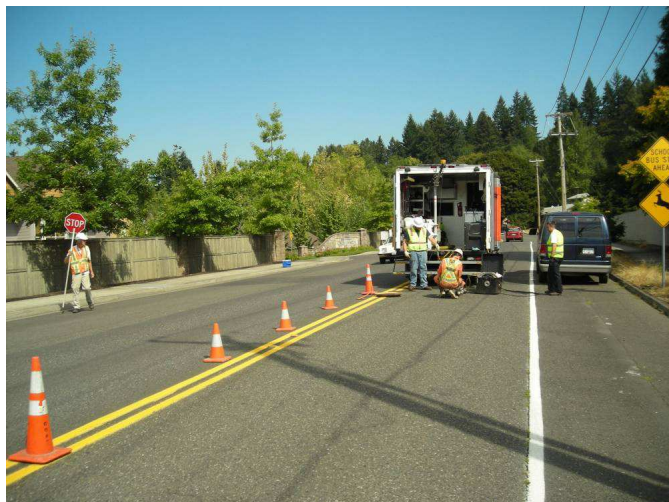
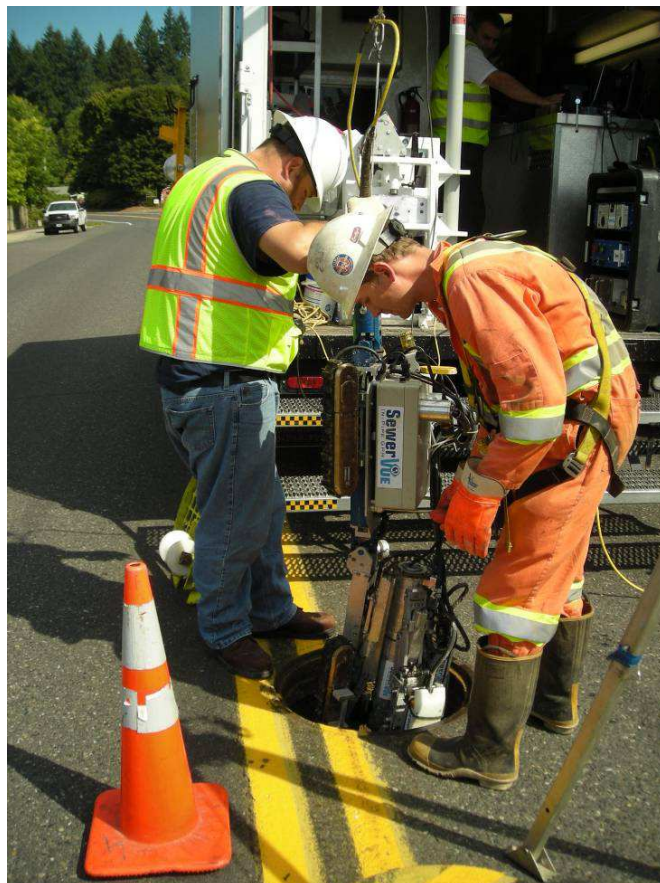
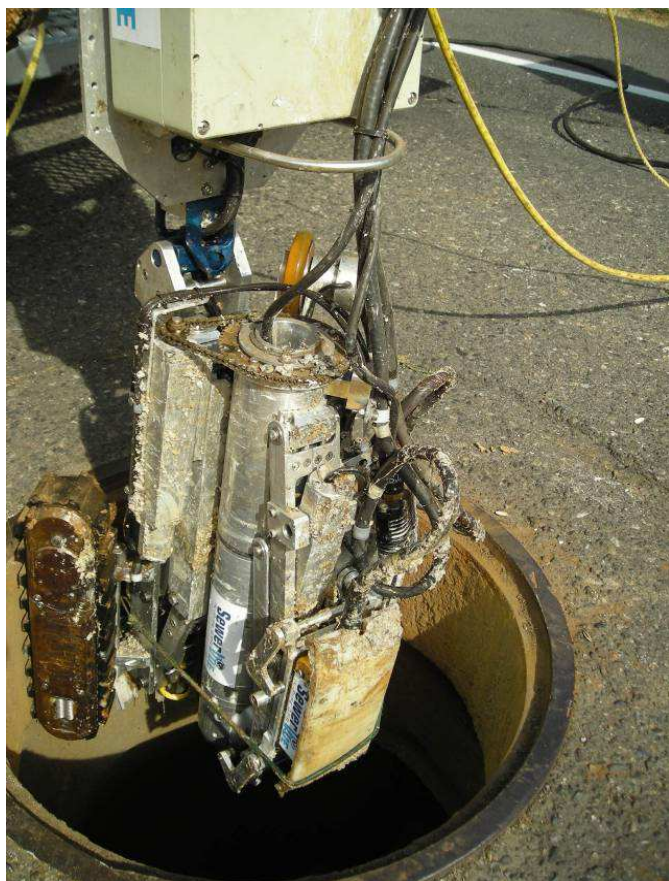
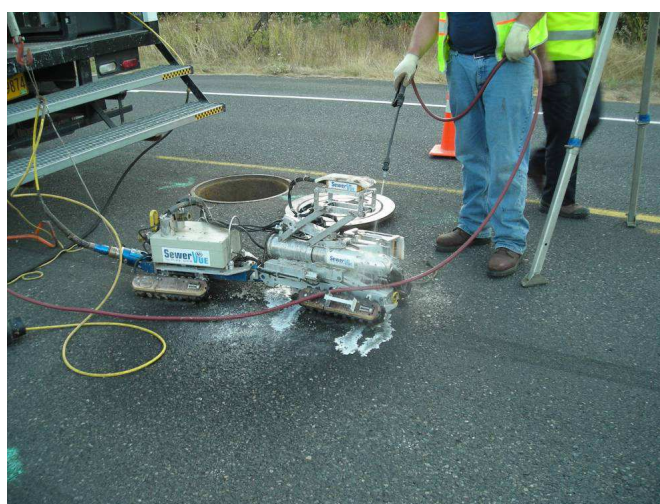
MH 8-50, MH 8-364

The entire 2,400 LF showed concrete surface spalling and buildup above the water level. The CCTV and PPR results showed evidence of infiltration at four locations. PPR results are summarized in Figure 5.
