Multi-Sensor Inspection: Assessing the Condition of Large Diameter Pipes with 3-D Digital Modelling

Csaba Ekes, Ph.D.

SewerVUE Technology Corp., #106-16 Fawcett Road, Coquitlam, BC, Canada V3K 6X9;
Phone: 604-421-0600; E-mail: info@sewervue.com

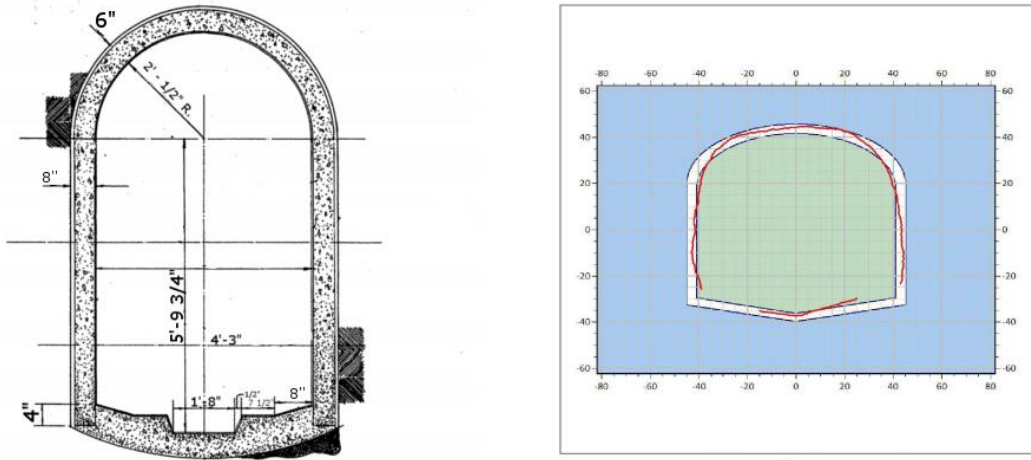
The owner of a reinforced concrete sewer tunnel located under a suburb of Denver knew the tunnel needed rehabilitation. However, they were facing a discrepancy between the reality of the tunnel and the original drawings. The tunnel was constructed over a period of 2 years in the late 1970's. This tunnel was irregularly-sized, ranging from 70 to 80 inches in diameter. The tunnel was horseshoe-shaped, with the invert having a wide V shape. This differed somewhat from the as-built drawings (Figure 3). The pipeline was constructed first by excavating the tunnel. Then, steel ribs were placed throughout. This was followed by lining the tunnel with minimum six-inch thickness shotcrete. The invert was constructed from cast-in-place concrete, placed following completion of the shotcrete coating. The final phase was the installation of a coal-tar epoxy coating for protection.

Figure 3. The tunnel's as-built drawing (left) compared to the profile as measured by LiDAR and sonar (right).

The primary intention of the inspection was to collect detailed geometric information necessary for designing a sliplining plan. The tunnel's irregular size and shape, as well as the lack of accessibility, made the rehabilitation project more complicated than usual.

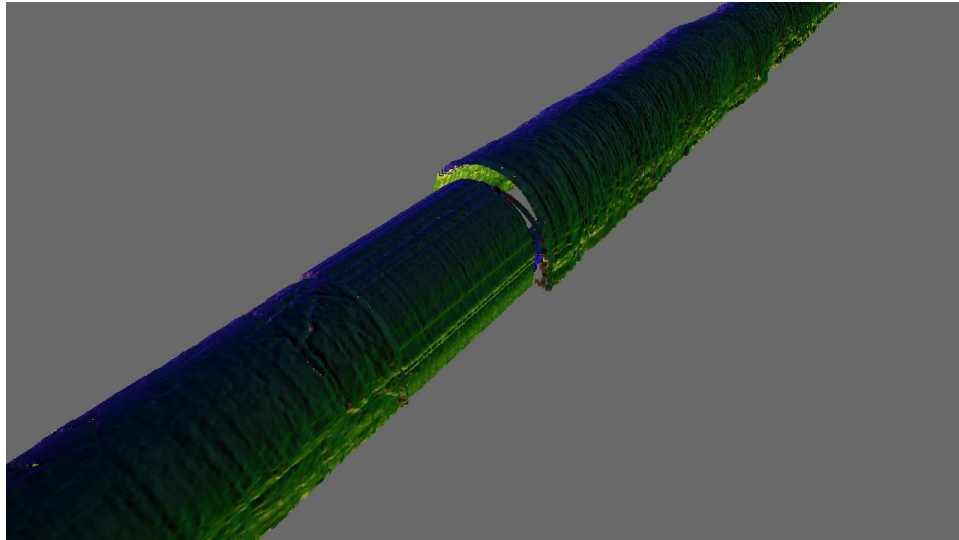
Analysis of the data revealed some notable features and anomalies within the pipe. 61.3 feet into the inspection, the pipe's dimensions decreased significantly and suddenly (Figure 4).

The first 61.3 feet measured 80 inches tall by 80 inches wide. After the change, the remainder of the pipe measured roughly 70 inches by 70 inches. There was a diameter variance throughout the length of the survey. In some sections, the diameter was reduced by as much as 5 inches, mostly coming from the crown being lower in those sections. Other sections showed outward bulges in the left or right wall, deflecting inward by as much as 5 inches. These irregularities are the result of the excavation method used to construct the tunnel.

Figure 4. 3-D model showing sudden diameter change.

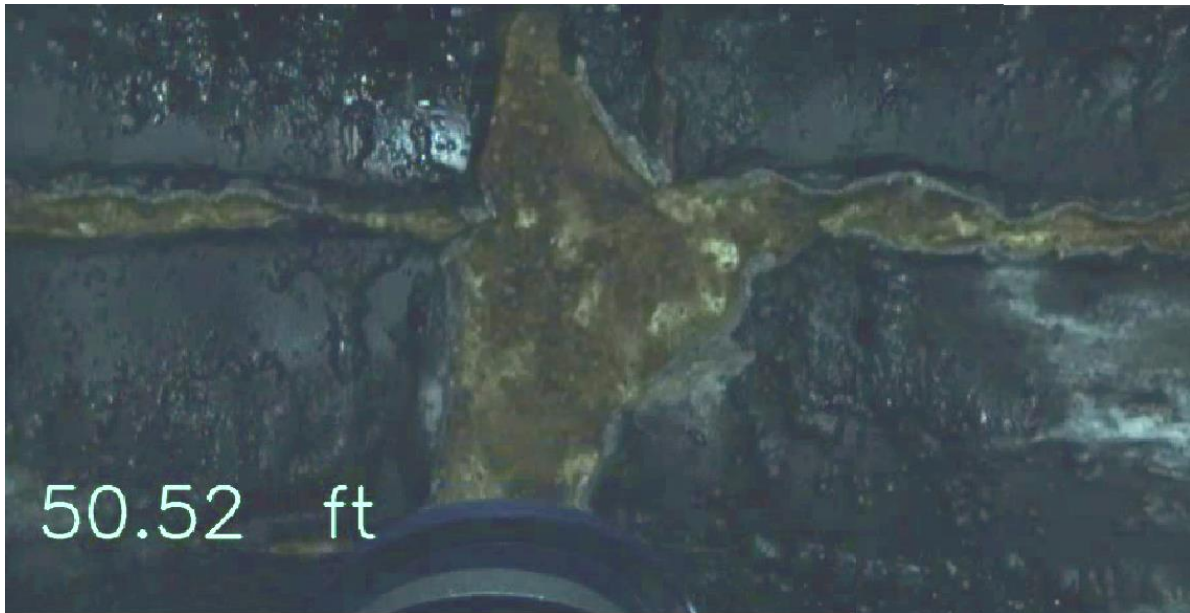
Throughout the survey, the coal-tar epoxy lining was seen to be delaminating and peeling away from the shotcrete beneath. Though this does not pose an imminent risk to the pipe's structure, it does illustrate the need for rehabilitating the pipe, as sections of exposed shotcrete will be more vulnerable to erosion and chemical attack. There were also localized instances of more significant damage or deterioration. These included sites where exposed shotcrete had begun to delaminate, (Figure 5) as well as a number of infiltration sites that were observed to be dripping and others where only stains were visible. There were calcium-like deposits observed throughout the survey, most notably in the form of long, root-like deposits growing from the crown of the pipe.

Figure 5. CCTV image of the coal-tar epoxy lining peeling away from the shotcrete below. This image shows the crown of the pipe between the 10 o'clock and 2 o'clock positions.

The data collected from this survey gave the owner the information necessary to design an effective rehabilitation plan. By knowing precise dimensions throughout the entire length, they could avoid the type of costly delays that may have occurred if irregularities were not discovered until rehabilitation had already begun. Multi-sensor inspections are useful for routine condition assessment, but are indispensable for cost-effective rehabilitation planning.

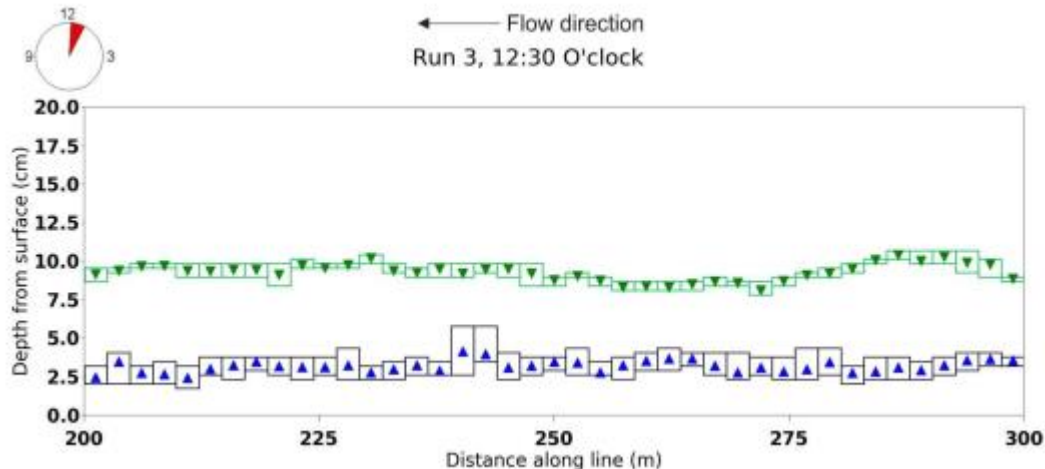
The Hobsons Bay Main comprised the second part of the survey. The Hobsons Bay Main is a 600 mm (24 inches) RCP sewer main. 572 m of this main was included in the scope of the survey. Starting from the access point and moving upstream, the LiDAR data from the survey showed the section between the deployment point and the next manhole to have increased wall loss compared to sections further upstream. This section was found to have significant sedimentation in it, and CCTV footage once again showed surface damage that appeared to be the result of chemical attack. PPR data showed rebar cover to be at least 15 mm throughout the length of the survey (Figure 7).

Figure 7. Example PPR data from Hobson's Bay Main. Green triangles represent the average wall thickness of each 2.44 m section. Blue triangles represent average rebar cover.
