# **Multi-Sensor Inspection: Advanced condition Assessment of Sewer Forcemains using MSI Technology**

This paper presents a case study wherein this workflow was used for digitizing, localizing, and mapping 16,860 linear feet with a 48-inch pipe that makes up the South Shore Force Main in Milwaukee, Wisconsin. Here we inspected the interior of this asset with 3D LiDAR and Video analysis. Advanced data processing methods allowed for unprecedented accuracy in reconstructing a digital double of this asset. Despite efforts to ventilate the pipe, visual conditions were limited during the inspection. This paper discusses the difference between a visual-only inspection and the insights learned from LiDAR intensity mapping in low visibility conditions.

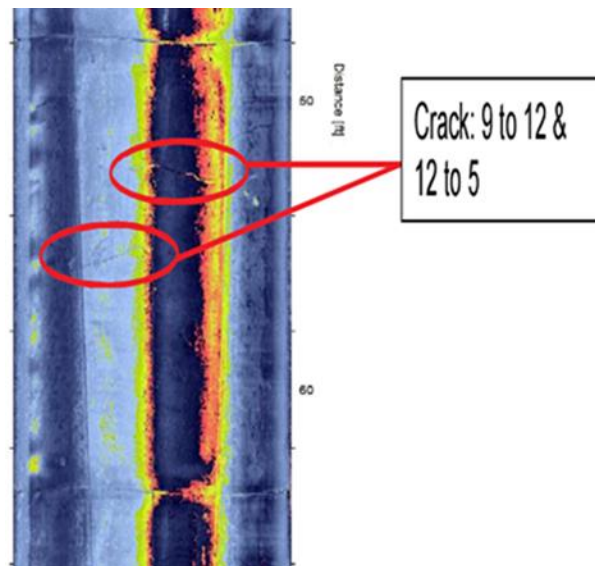
**Figure 5: Example: snakeskin chart showing cracks.**

SewerVUE's video reviewers did not see any indication of cracks within the pipe. The LiDAR data painted a different picture with evidence of widespread cracking throughout four of the surveyed segments, totaling dozens of instances. Most of the cracks ranged from 4-8 feet long and were present at many clock positions.

Despite the prevalence of the cracking, it was not visible on the CCTV footage. Upon analysis of the LiDAR data, SewerVUE discovered it. figure 5

Snakeskin charts show an unwrapped 2D representation of the pipe’s internal geometry. The chart displays observed variance from the standard dimensions through color gradation. Figure 5 below shows an example of this.
