## **Applications of Pipe Penetrating Radar for Advanced Pipe Condition Assessments: the Clark Regional Wastewater District (WA) Case Study**

This paper presents recent advancement of PPR inspection technology together with the robotic, Vancouver, WA case study. Clark Regional Wastewater District, the owner of the Salmon Creek Interceptor and St Johns Trunk lines commissioned a condition assessment on the 21, 24 and 36 inch concrete lines. For the St. Johns Trunk, a 36-inch line, corrosion was suspected and evidence was observed visually by CCTV. Chemical dosing had been implemented to minimize continued corrosion due to vapor-phase H<sub>2</sub>S, but the District wanted to quantitatively determine the extent of corrosion and if/when future rehabilitation would be needed. PPR confirmed the upstream-most segment had corroding/missing reinforcement and reduced wall thickness.

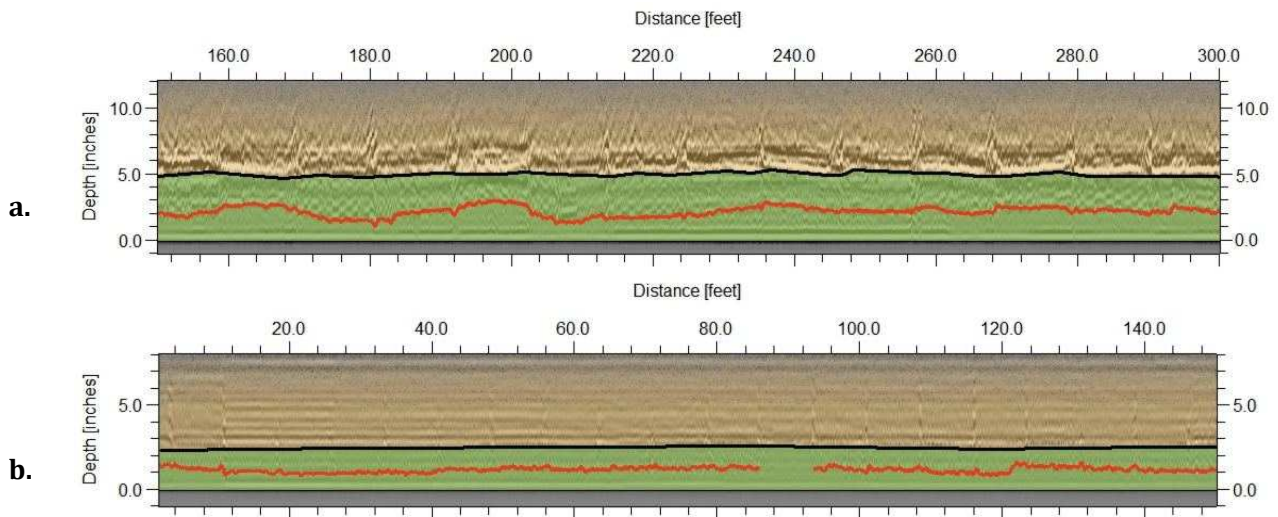
**Figure 4:** PPR inspection results showing wall thickness and rebar depth superimposed on the processed radar sections. Pipe wall thickness is marked by continuous black line, rebar shown as red lines (a. St Johns Trunk; b. Salmon Creek Avenue Trunk).

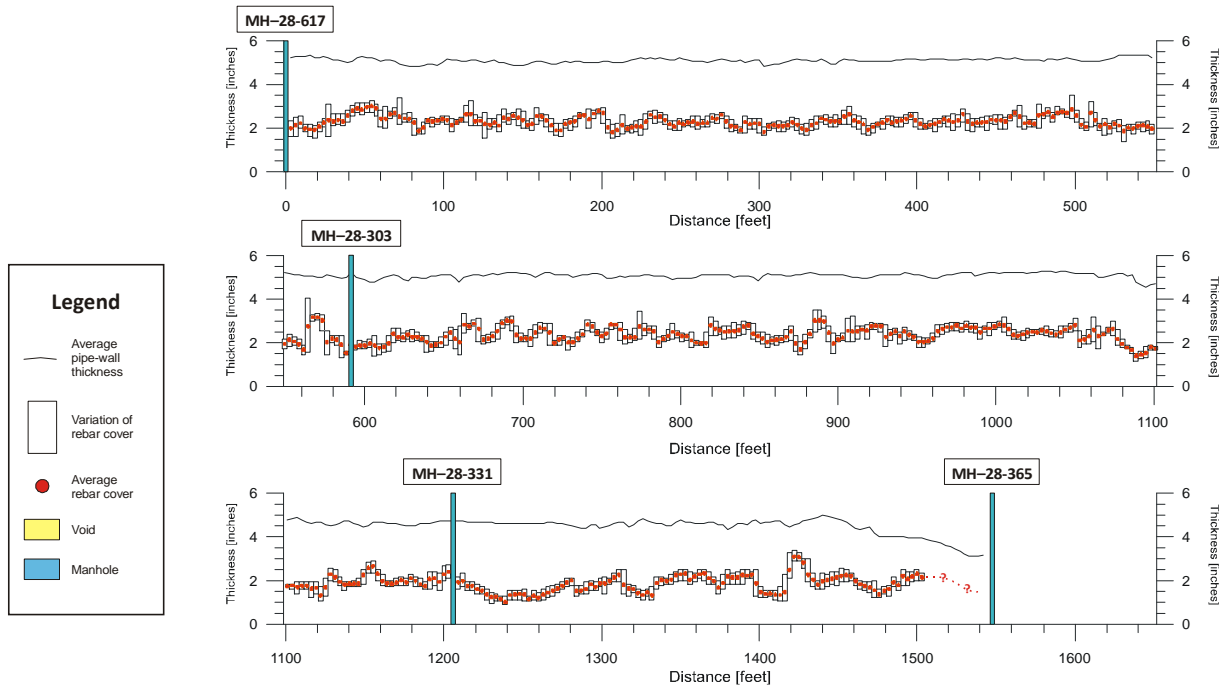
The PPR data show variations in pipe wall thickness, as well as location, depth and spacing of rebar. The results show that pipe wall thickness is around 5 and 5.25 inches, between 0 and 1085 ft. It is between 5 and 4.5 inches between and 1085 and 1460 ft, and between 4.5 and 3.75 inches between 1460 ft and 1545 ft at the upstream manhole MH 28-377 where corrosion appears most severe.

Rebar cover varies between 1 and 4 inch. Rebar signal is weak between 1475 and 1505 feet and very weak or appears to be absent between 1505 and 1545 feet. A minor void was detected at 27.5 ft at 10 o'clock position. This voids is approximately 4 feet long and 4 inches high.

Overall, the majority of the 36-inch trunkline is structurally in fair to poor condition. Inspection of the upstream-most pipe segment revealed evidence of severe corrosion. The PPR data indicated less concrete rebar cover at the upstream section of the trunkline and a loss of wall thickness as the robot moved upstream. Assuming the initial pipe design considered the railroad loading and appropriate dead loads, the loss of wall thickness and suspected corrosion in the reinforcement indicates that the existing pipe may be compromised structurally. PPR results for St Johns Trunk are summarized in Figure 5.

**Figure 5:** Summarized PPR results for St Johns Trunk.

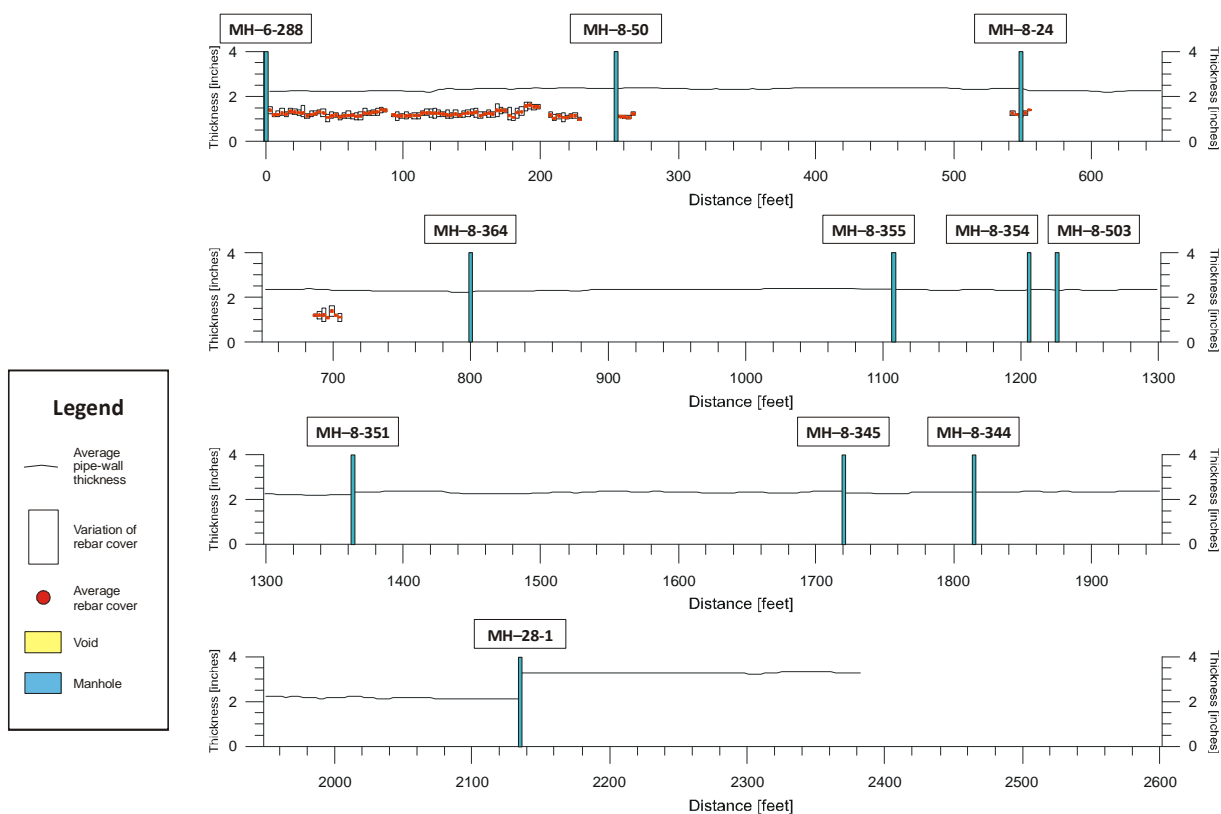
The PPR results are summarized in Figure 6. The PPR results are displayed as the summary results from the 2.6 GHz antennas at 11 and 1 o'clock positions. Pipe wall thickness is 3.25 inch with little variations. What is striking is the apparent lack of rebar. With the exception of 0 to 225 feet between MH 6-288 and MH 6-850 with the exception of 255 ft to 270 ft and 685 ft to 707 ft there appears to be no rebar reflection on the PPR profiles. Signal quality is otherwise very good. This leads us to the conclusion that there is no rebar in the majority of the pipe. Where rebar is present it appears to be uniform with adequate cover and little variation in depth. PPR scanning did not detect any voids in the fill material around the pipe.

**Figure 6:** Summarized PPR results for Salmon Creek Avenue Trunk.

Structurally, the majority of the 21-inch-diameter portion of the pipe revealed evidence of concrete corrosion. The interior cement layer had either corroded or eroded, resulting in projecting aggregate. On the recommendation of Brown and Caldwell the initial PPR results were recalibrated with data from a follow-up man-entry pipe wall thickness measurement.
