New Developments in Multi-sensor Condition Assessment Technologies for Large Diameter Pipe Infrastructure

Csaba Ékes, PhD, PGeo.

SewerVUE Technology Corp. - 7993 Enterprise Street - Burnaby, BC, Canada - V5A 1V5
Tel: 1-888-973-9378 - email: info@sewervue.com

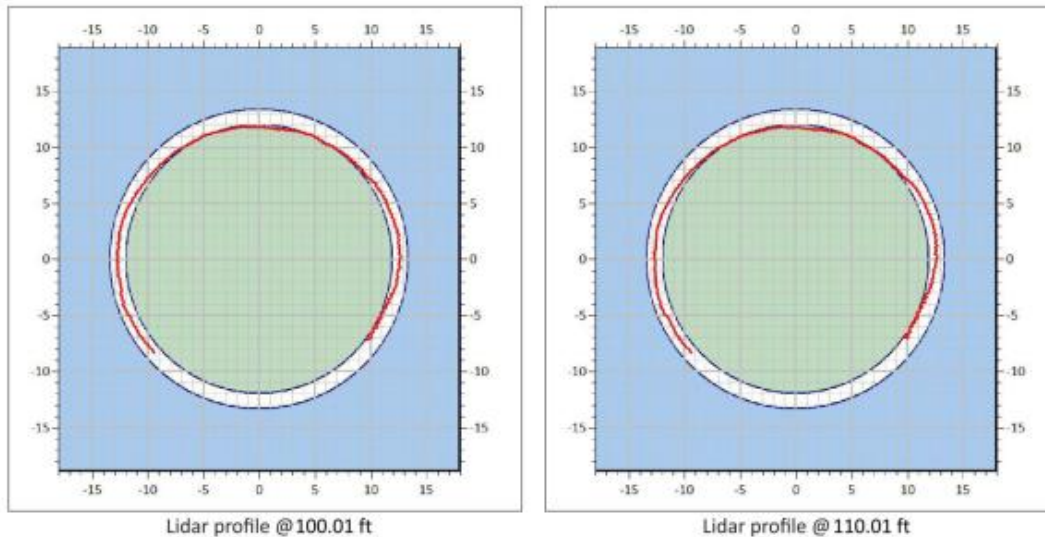
Figure 1 - Example of LiDAR cross-sections from a delivered report

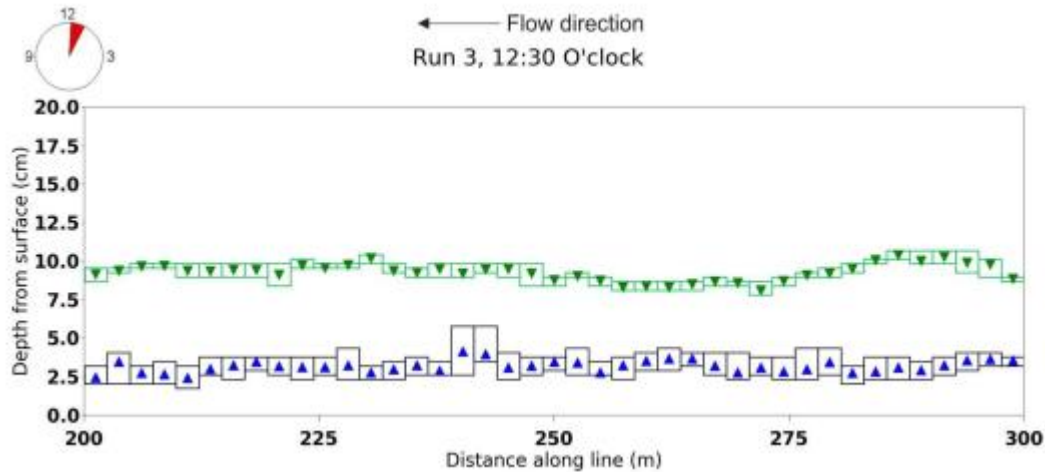
The Hobsons Bay Main comprised the second part of the survey. The Hobsons Bay Main is a 600 mm (24 inches) RCP sewer main. 572 m of this main was included in the scope of the survey. Starting from the access point and moving upstream, the LiDAR data from the survey showed the section between the deployment point and the next manhole to have increased wall loss compared to sections further upstream. This section was found to have significant sedimentation in it, and CCTV footage once again showed surface damage that appeared to be the result of chemical attack. PPR data showed rebar cover to be at least 15 mm throughout the length of the survey. (Figure 3)

Figure 3 - Example PPR data from Hobson's Bay Main. Green triangles represent the average wall thickness of each 2.44 m section. Blue triangles represent average rebar cover.

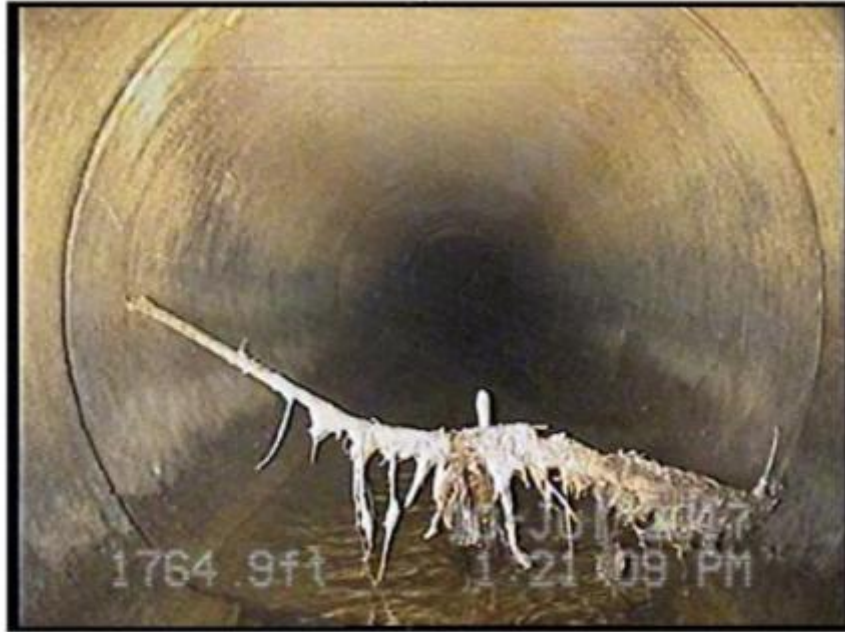
The Upper Woods Creek Bypass is constructed from RCP, and measures 600 mm (24 inches) in diameter. The bypass is 1605.7 m (5268 ft.) in length, and was inspected using the Surveyor, a tracked ROV mounted with LiDAR, CCTV, and PPR equipment. Despite the length of the pipe, the inspection could be done from just one access point near the middle of the line. CCTV visuals collected from the pipe showed it to be in generally good condition. The only noted defects were a number of roots intruding at joints, and some scattered structural defects. (Figure 5) Though not officially coded as a defect, efflorescence was present along a significant portion of the pipeline. Efflorescence is the term for salt deposits on the surface of a porous material that become visible after the evaporation of the water. On its own, this does not pose a significant problem. However, as the concentration increases over time, the osmotic pressure on the pipe wall also increases, which can result in damage to the concrete.

Figure 5 - CCTV image showing a significant intruding root
