# Multi-sensor inspection robot shows benefits of pipe penetrating radar

BY CSABA EKES, SEWERVUE TECHNOLOGY CORP.

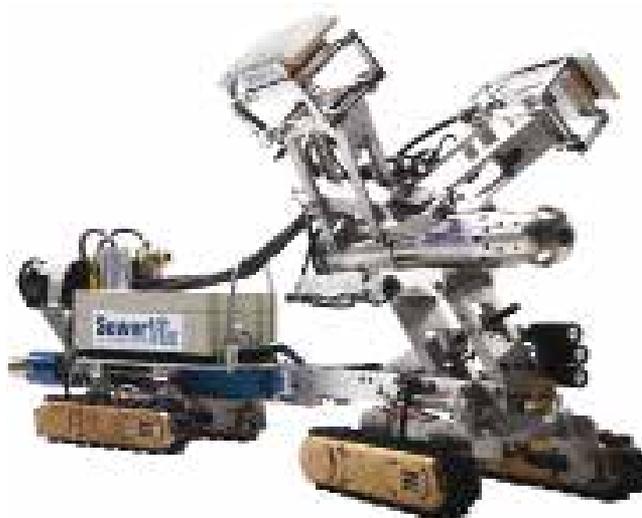
**The SewerVUE Surveyor is the first commercially-available inspection robot to use CCTV, LIDAR and PPR to inspect underground pipes.**

The SewerVUE Surveyor is the first commercially-available multi-sensor inspection robot that uses visual and quantitative technologies including CCTV, LIDAR and PPR to inspect underground pipes. This fourth generation PPR pipe inspection system is mounted on a rubber tracked robot and equipped with two high-frequency PPR antennae. Radar data collection is obtained via two independent channels in both in and out directions, providing a continuous reading on pipe wall thickness and voids outside of the pipe. CCTV data is recorded simultaneously and is used for correlation with PPR data collection.

of the inside of the pipe. LIDAR technology employs a scanning laser to collect inside pipe geometric data which is then used to determine pipe wall variances from a manufactured pipe specification. LIDAR data is correlated with an onboard inertial navigation system that can accurately map the x, y, and z coordinates of the pipe without the need for external references. LIDAR and x, y, and z data collection was not part of the scope for this project. The SewerVUE Surveyor is equipped with three cameras (front, antenna and back).

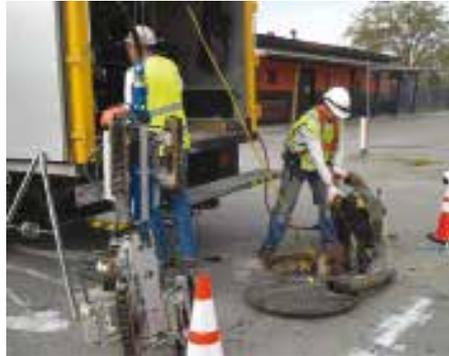
**Deployment of the SewerVUE Surveyor at the Del Norte Trunk Sewer in Stockton, California.**

The City of Stockton Department of Municipal Utilities commissioned to conduct a high-frequency PPR survey to inspect sections of the Del Norte Trunk Sewer in Stockton, California. The Del Norte Trunk Sewer is a 36-inch reinforced concrete pipe (RCP) with a 0.7-inch thick fibreglass liner that reduced the inner diameter to approximately 32.5 inches. The total inspected length was 4,264 feet. The objective of the PPR survey was to determine the condition of the approximately 55-year-old lined RCP by mapping its wall thickness, rebar cover and detecting voids or other anomalies within or outside the pipe wall. The pipe experienced failures in the past and the fibreglass liner has at places also separated from the original RCP pipe wall.

The 4,264 feet of PPR data from the Del Norte Trunk Sewer indicated sufficient rebar cover and no void type anomalies on any

of the processed PPR profiles. Wall thickness including the grouted fibreglass liner was interpreted to be four inches with little variation over the inspected length. The system used in Stockton can be adjusted for 21 to 60-inch diameter pipes; the PPR antennae can be rotated between the nine and three o'clock positions.
