**North American Society for Trenchless Technology (NASTT)
NASTT's 2016 No-Dig Show**

TA-T1-05

Quantitative pipe condition assessment with Pipe Penetrating Radar

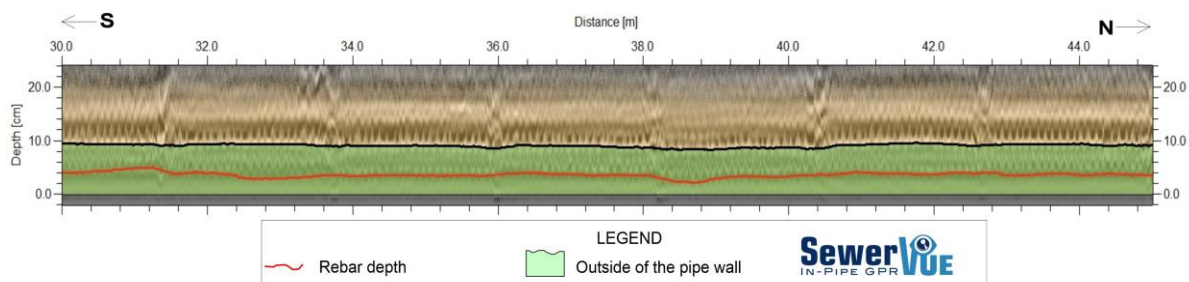
Figure 4. “Classic view” PPR results for the Bear Creek Interceptor, Surrey, BC.

2D line data were collected on the crown of the pipe. The 2.3GHz antenna frequency provided good quality data and signal penetration to allow analysis to a depth of 20 to 30 centimeters from the inside pipe wall surface (Figure 4).

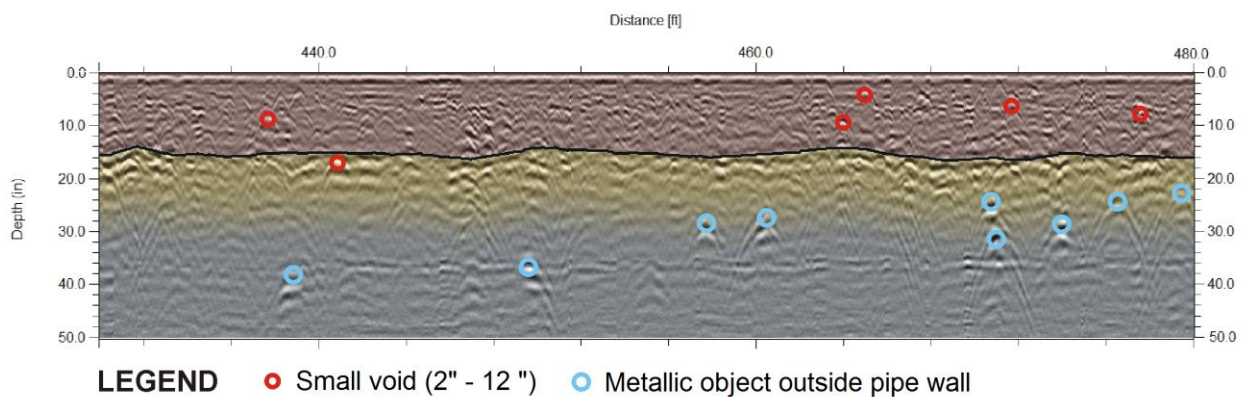
Figure 9. Interpreted PPR profile from a 120 inch diameter brick lined sewer.

The PPR profiles have a depth scale in inches on the vertical axis, corresponding to about a 50 inches total depth of investigation (Figure 9). All the collected PPR data are of high quality and rich in detail.

The interpretation was based on the careful analysis of certain reflections that show the expected brick liner/fill interface in all of the depth slices in all directions. A given reflection was compared to the surrounding signal strength. A processed and interpreted depth profile is shown in Figure 9.

The interpreted anomalies were recorded on the processed PPR profiles and cross referenced with clock position and survey distance features. Areas of void type reflections are sometimes seen along the liner-fill interface (Figure 9). These zones are conspicuous by their pronounced irregular “bright spot” anomalies with higher amplitude and lower frequency (i.e. wider banding) relative to their surroundings. Void type anomalies were divided into three groups: small voids (2 -12 inch) medium voids (1 -3 feet) and voids larger than 3 feet. No voids larger than 3 feet were identified on any of the surveyed lines. The results are summarized and tabulated according to void size and location within the pipe (Table 1).

The three courses of bricks can be identified on some of the profiles some of the time (Figure 9). Well defined hyperbolic arches within the three courses of bricks were interpreted as small voids (Figure 9). Concentrated hyperbolic arch pattern indicate reflections and scattering from sides of individual bricks. This pattern may indicate missing mortar and these were identified as possible damaged zones.

A total 2040 ft of the sewer was surveyed with a hand held 1 GHz frequency PPR system. Signal penetration was between 20 to 40 inch depth, the data are of high quality. The most prominent feature on all the profiles is the pattern change often accompanied with a near horizontal, wavy interface at 16 ± 4 inch. This feature was interpreted as the brick liner/backfill interface (Figure 9). The observed anomalies were grouped into three categories in relation to this interface:
