IN-PIPE GROUND PENETRATING RADAR FOR NON-DESTRUCTIVE EVALUATION OF PVC LINED CONCRETE PIPE

By Samuel T Ariaratnam¹ and Noel Guercio²

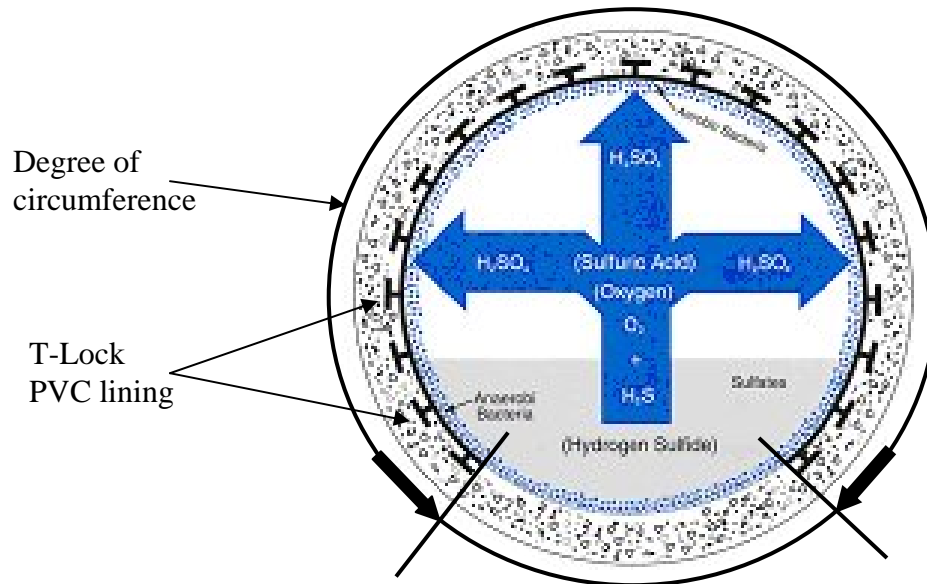
Figure 1. Cross-sectional view of reinforced concrete sewer pipe with T-Lock liner (Ameron 2001)

reinforced concrete pipe lined with a polyethylene sheet. As illustrated in Figure 1, the liner is fixed to the concrete with imbedded “Tees” that run the length of the pipe section. This prevents the liner from detaching itself from the pipe. The degree of lining varies depending on what has been specified and is intended to protect the concrete from harmful sewer gases including hydrogen-sulfide.

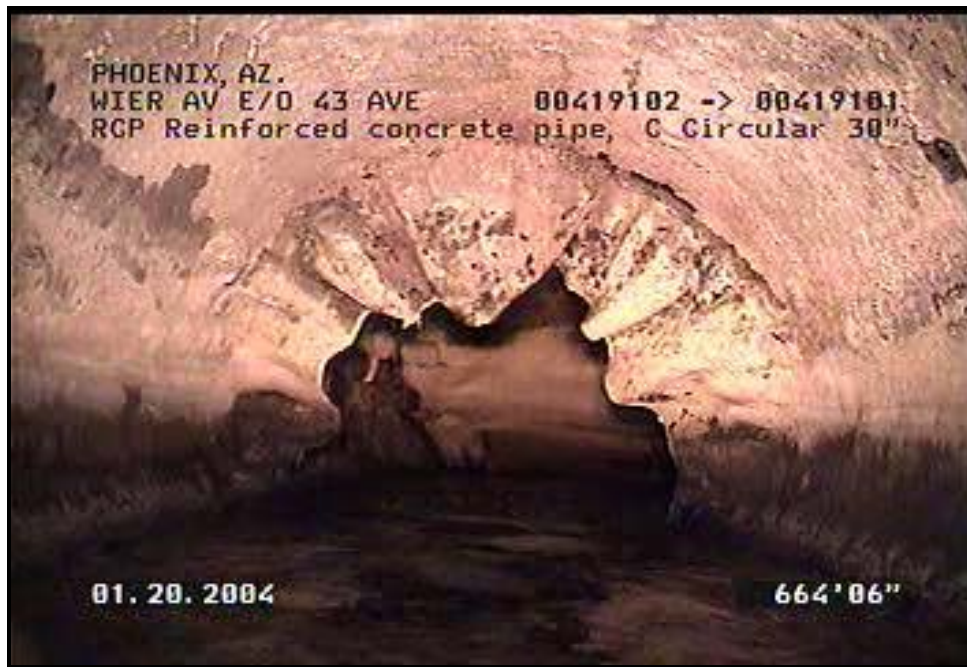
Figure 2. Detached liner

Various defects were observed during the CCTV visualization inspection. Condition assessment of the results found that a total of 537 out of 2,451 total defects (22%) were considered to be minor and given a condition grade of 1. Subsequently, these were omitted from the pipe segment ratings and the subsequent tables and figures. Common defects observed during the CCTV inspection included pinholes in the liner, blisters in the liner, detached weld strips, and holes in the liner. Several of these defects are illustrated in Figure 2. A breakdown of the Grade 2 through 5 defects is presented in Table 2.

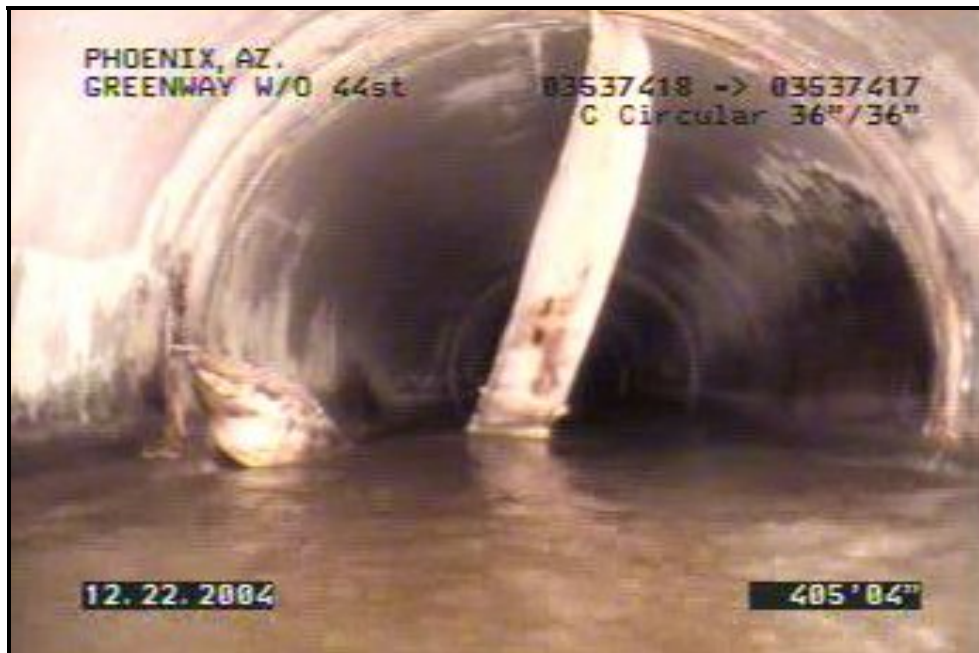
Figure 3. Detached weldstrip

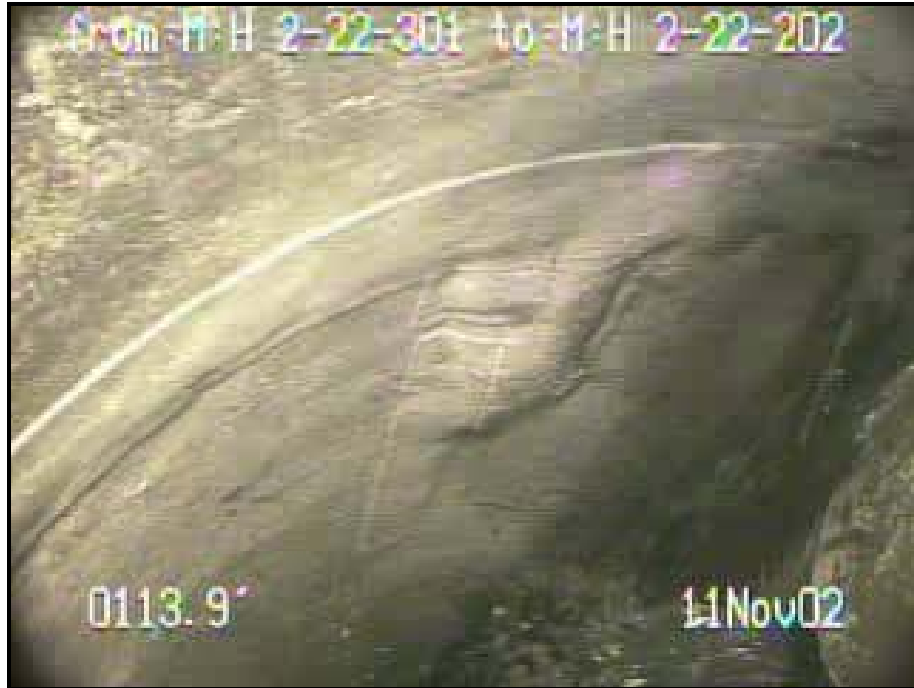
Figure 4. Blister in liner

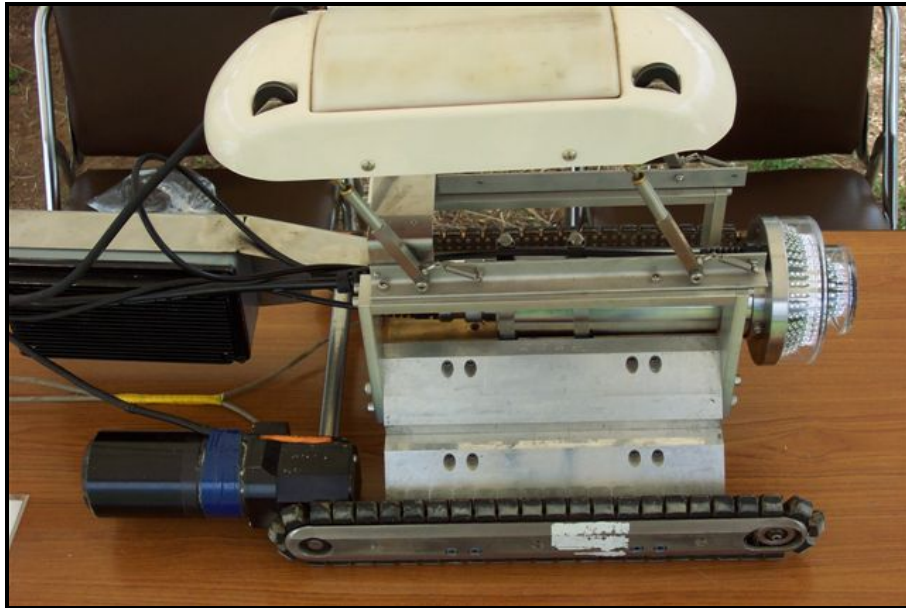
Figure 5. Prototype inspection robot with gpr unit

Field testing of a prototype unit was conducted in Tskuba, Japan in the fall of 2003 to determine whether readings could be made. Defects were manually created in the concrete behind sections of lined pipe. The first prototype, illustrated in Figure 5, performed well in the trials and was brought to Phoenix for a pilot project.

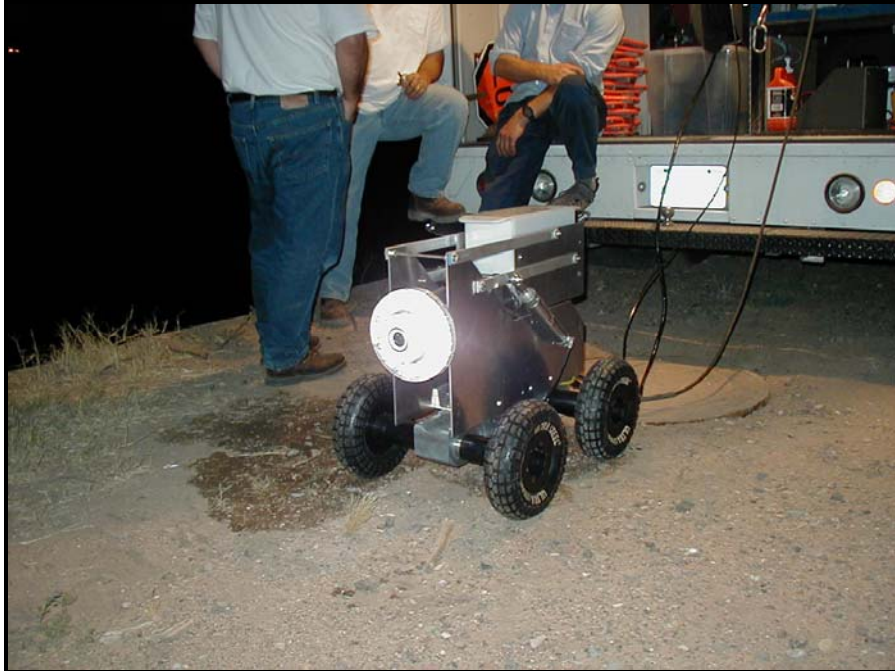
Figure 6. Second generation wheeled inspection robot with gpr

Due to the pipe size and potential flow conditions, it was determined to use a wheel robotic body rather than the track body used in the Japanese field tests. The second generation robot, illustrated in Figure 6, capture data behind the liner at pre-positioned liner defect positions along several pipeline sections. Unfortunately, a limitation was the fact that information could only be captured at the 12 o’clock position due to the fixed GPR unit.

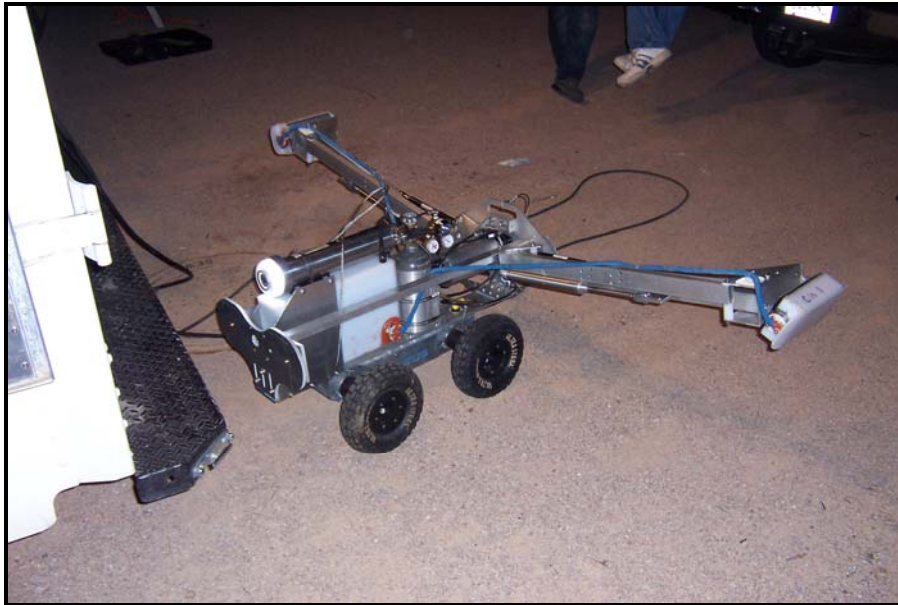
Figure 7. Third generation wheeled inspection robot is multiple gpr units

The third generation robot, illustrated in Figure 7, solved any problems associated with clock face positioning through the use of multiple gpr units attached to two arms. This enables the unit to capture defect information anywhere along the 9 o’clock to 3 o’clock positions of a pipe section. An example of the corresponding ground penetrating radar results is shown in Figure 8. The top results show the defect areas in relation to a folded view of the pipe, while the bottom results show a front view of the liner tears.

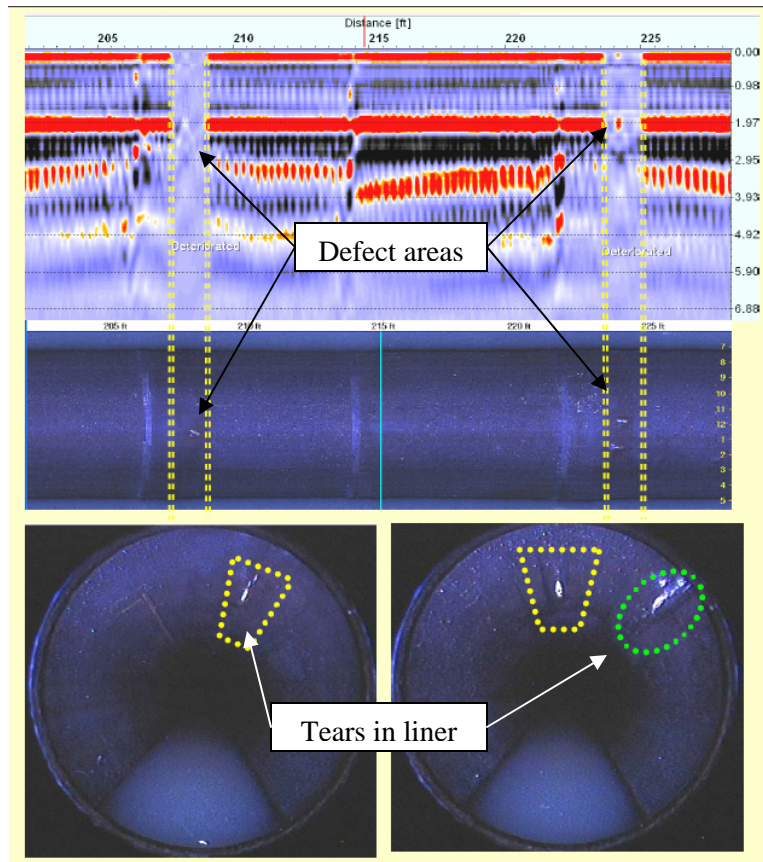
Figure 8. In-pipe ground penetrating radar results

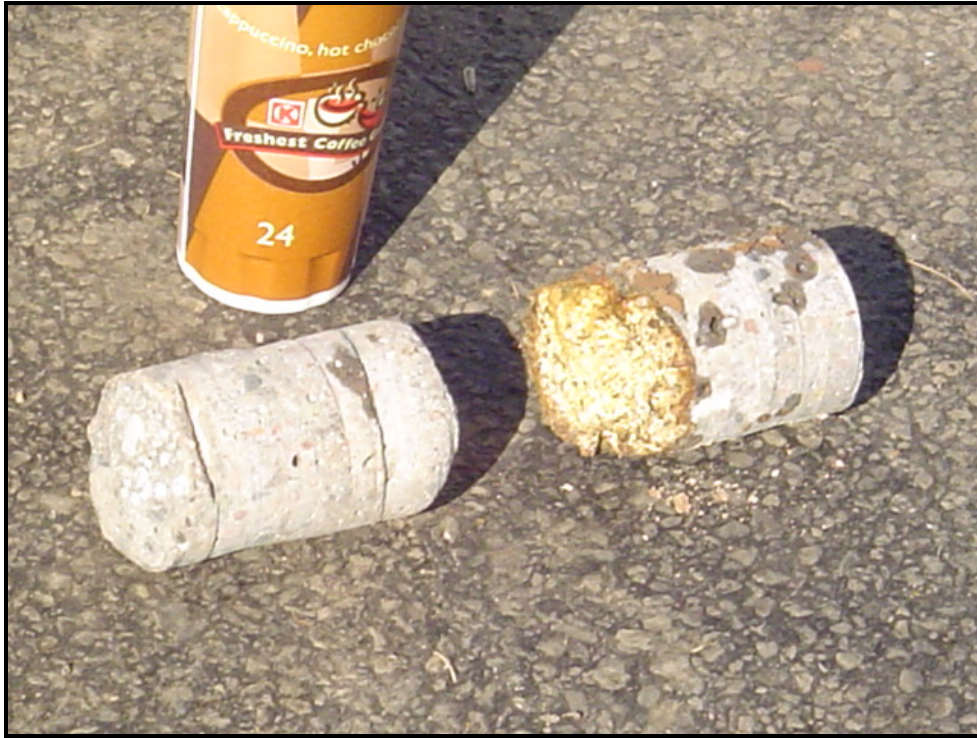
Figure 9. Core samples from 750 mm concrete pipe section

Core samples of pipe walls were obtained from two different locations to provide a visual verification of suspected problem areas detected by the ground penetrating radar. In both locations, a 5 m deep, 2.4 m wide, 7.6 m long trench was excavated at predetermined locations with a box shoring used for stabilization. A GPR survey was performed on the exterior surface of the top of the reinforced concrete pipe to determine the exact location to extract the coring sample. Two 75 mm diameter samples were recovered at each of the two locations and preserved for laboratory testing of compressive strength (Edwards and Nowaczyk, 2005). One sample was at a suspected defect location, while the other was in an unaffected section of the concrete pipe wall for comparison. Table 3 presents the results of the compressive strength tests performed to ASTM C39-01 standards.

The cores samples (Figure 9) verified the results found using the non-disruptive in-pipe ground penetrating radar unit transported on a robotic platform. Discoloration of the core samples and diminished compressive strength measures further demonstrate the problems that could occur if hydrogen-sulfide gases were to penetrate the liner and attack the concrete wall.
