Inspecting Twin 42” Reinforced Concrete Pipes with Pipe Penetrating Radar Supplemented by LiDAR

Csaba Ékes, Ph.D., PGeo

SewerVUE Technology Corp. #106-16 Fawcett Road - Coquitlam, BC, Canada – V3K 6X9
Tel: 604-421-0600 Email: info@sewervue.com

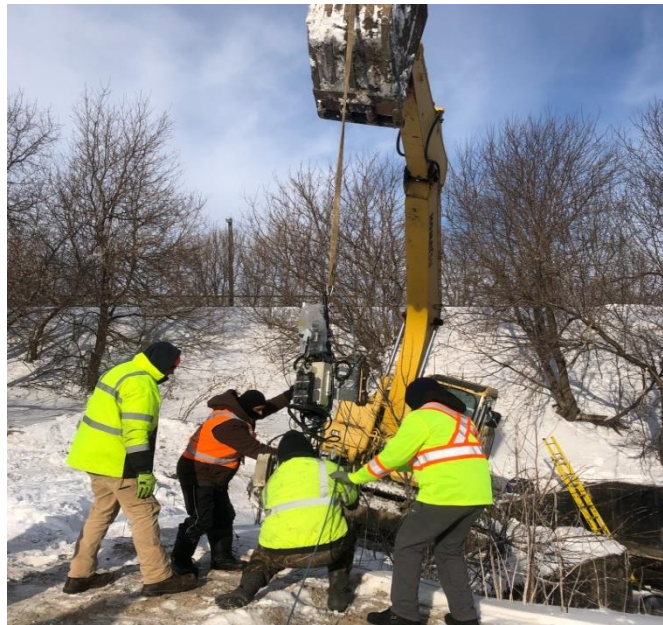
The two 523-foot-long 42-inch diameter reinforced concrete combined storm and sewer pipes were inspected with pipe penetrating radar for a total length of 1002 feet. The Surveyor provided an ideal stable platform to operate the LiDAR’s since the quality of the antenna-pipe wall contact is critical to the success of PPR investigations (See Figure 4). The 9, 10, 11, and 12 o’clock positions were investigated.

Figure 4: Surveyor deployment in the RC pipe

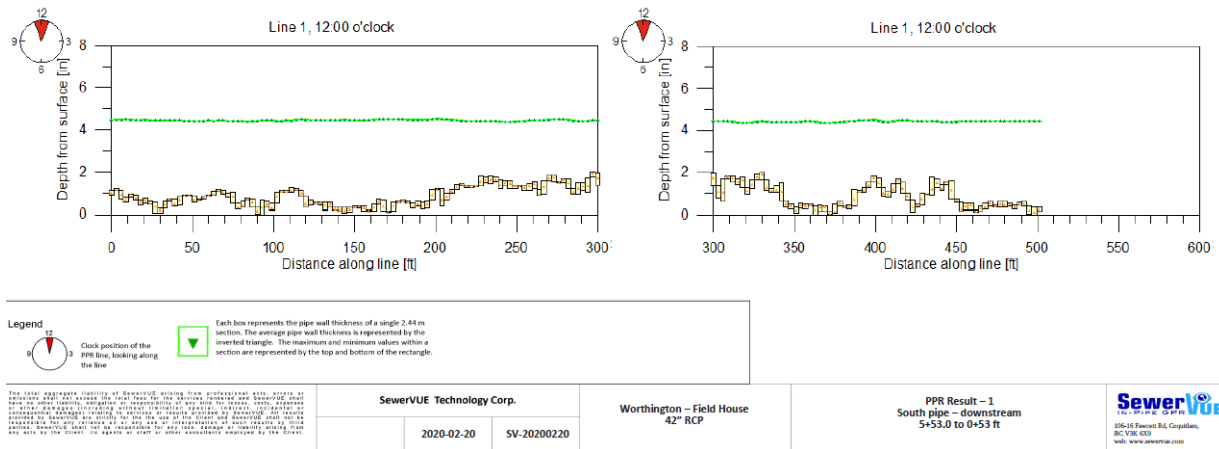
Proprietary software was used to apply different corrections, filter, and gain functions to the PPR data. This processing enhances anomalies and allows for a clearer interpretation of the results. The results of the PPR data are then presented as two-dimensional depth slices (see figure 6).

Figure 6. LiDAR and CCTV showcasing an anomaly in the south pipe

Both RCPs had undergone differential settlement however the results of the inspection concluded that the North pipe exhibited 2.4 times more anomalies than the South pipe, highlighting voids outside its upper pipe walls. Both pipes’ cross-sections have been deforming in a vertical direction which was confirmed by LiDAR.

LiDAR data showed deformation of the pipe but no significant issues with wall thinning. The pipe penetrating radar data suggested the pipe wall thickness was 4.5 inches, giving evidence of a previous manufacturing defect. This resulted in the reinforced concrete pipes lying too close to the inner pipe wall which can result in problems with the structural integrity of the pipes. The inspection resulted in determining a need for rehabilitation. The City of Worthington will commence the renovation of the recreational center accordingly and the Union Pacific Railroad will be able to continue operation after pipe rehabilitation maintenance.
