**North American Society for Trenchless Technology (NASTT)  
NASTT's 2017 No-Dig Show**

**Application of High Frequency Pipe Penetrating Radar in Asbestos Cement Pipes**

Csaba Ékes, SewerVUE Technology Corp., 7993 Enterprise St., Burnaby, BC, Canada V5A 1V5; Tel: 1-888-973-9378, email: info@sewervue.com

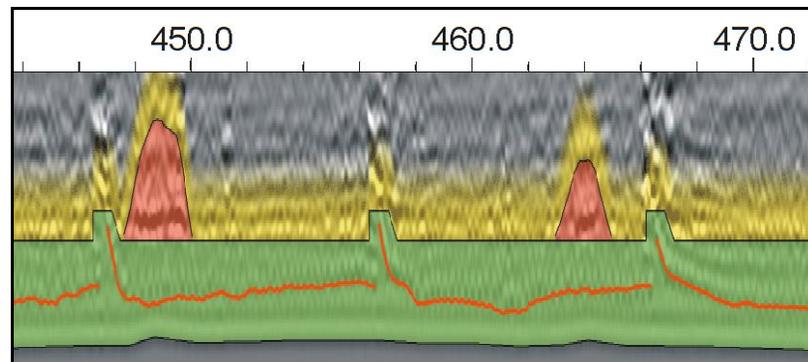
Figure 1. Robotic PPR data is displayed with the interpretation overlaid.

The recorded raw data is processed in order to enhance anomalies at deeper levels. Frequency filtering is used to remove noise. SewerVUE’s proprietary RadART software package was used for applying different correction, gain and filter functions. The interpretation is then superimposed on the processed PPR profiles (Figure 1).

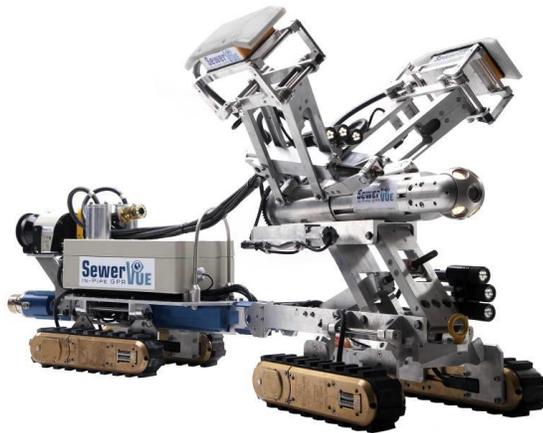
Figure 2. The fourth generation SewerVUE Surveyor multi sensor inspection robot equipped with HD pan tilt zoom CCTV, PPR and LIDAR.

The SewerVUE Surveyor is the first commercially available multi sensor inspection (MSI) robot that uses visual and quantitative technologies (CCTV, LIDAR, and PPR) to inspect underground pipes (Figure 2). This fourth generation PPR pipe inspection system is mounted on a rubber tracked robot and equipped with two high-frequency PPR antennae. The system used in Everett, WA can be adjusted for 21 to 60-inch diameter pipes, the PPR antennae can be rotated between the nine and three o’clock positions. Radar data collection is obtained via two independent channels in both in and out directions, providing a continuous reading on pipe wall thickness and locating voids outside the pipe. CCTV data is recorded simultaneously and is used for correlation with PPR data collection.

The sensors mounted on the robot take quantitative measurements of inside pipe walls. LIDAR technology employs a scanning laser to collect inside pipe geometric data which is then used to determine pipe wall variances from a manufactured pipe specification. LIDAR data is correlated with an onboard inertial navigation system (INS) that can accurately map the x, y, and z coordinates of the pipe without the need for external references.

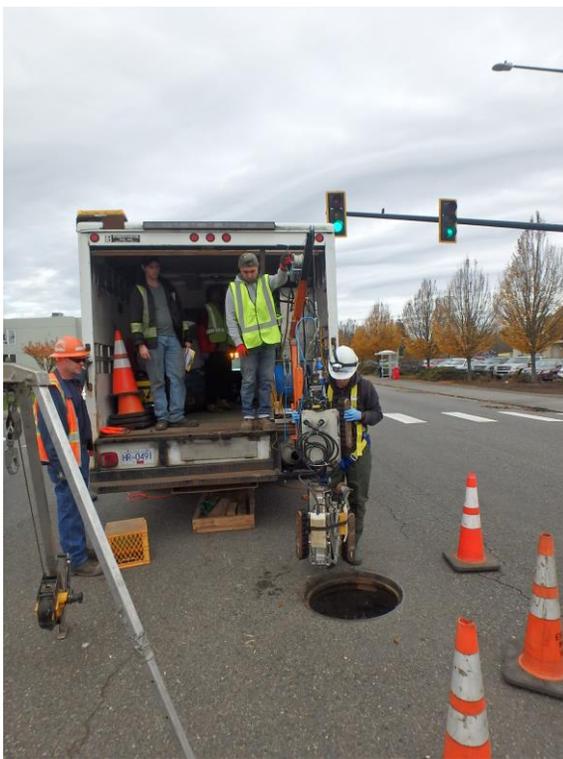
The first case study took place in a 100 year old 36 inch diameter brick lined sewer in Everett, WA. The pipe is a combined sewer that, during carries sewage and runoff under the city's main thoroughfare (Figure 3).

Figure 3. Deployment of the SewerVUE Surveyor robot at the Broadway Sewer main, Everett, WA.

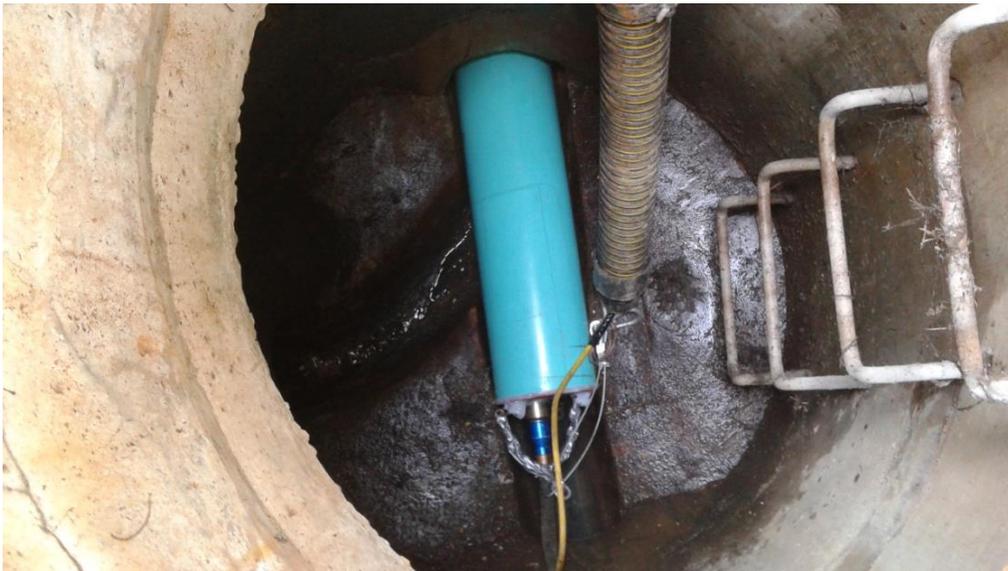
Figure 5. Deployment of the AC Pipe Scanner at the Harbourgreene drive sewer in Surrey, BC, Canada.
