New Developments in Multi-sensor Condition Assessment Using LiDAR, Sonar and CCTV

Csaba Ékes

SewerVUE Technology Corp., 7993 Enterprise St., Burnaby, BC, Canada
V5A 1V5; Tel: 1- 888-973-9378, e mail: info@sewervue.com

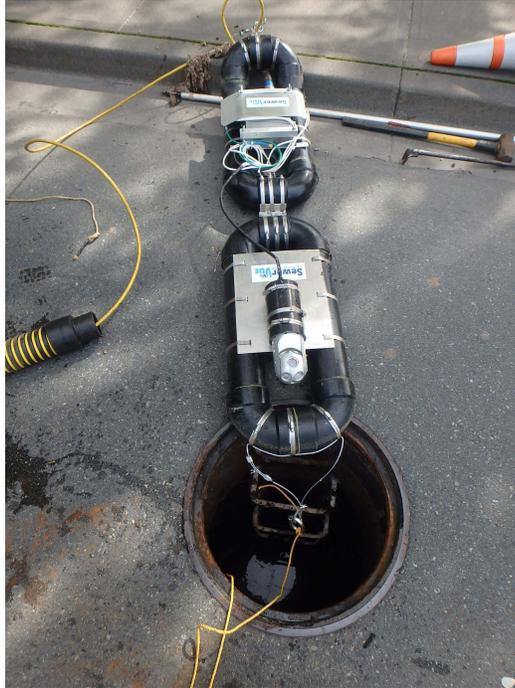
Figure 1. The second generation SewerVUE Multi-sensor Pipe Inspection System (MPIS) before deployment.

The Multi-sensor Pipe Inspector System (MPIS) used for the project is a float based inspection system that uses visual and quantitative technologies (CCTV, LiDAR, and Sonar) to inspect the condition of underground pipes. This tethered, modular and customizable second generation MPIS was powered through a 1010 m long tether cable (Figure 1). CCTV, LIDAR and sonar data is acquired simultaneously in both in and out directions. First a guide rope was installed then the inspection platform is pulled through.

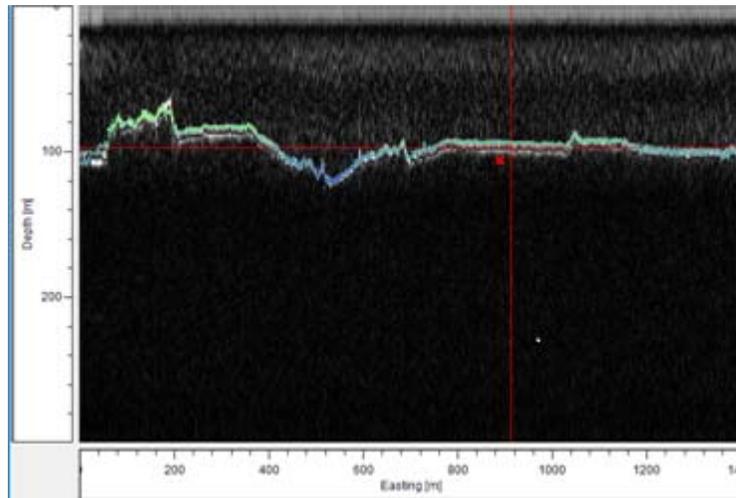
Figure 2. Sediment level and distribution in the North Surrey, BC, Canada interceptor.

The primary objective was to measure the height, volume and distribution of deposited sediment (Figure 2) for the subsequent PPR inspection. Knowing the sediment depth and its distribution was critical for designing the suitable antenna enclosure for the subsequent PPR survey.

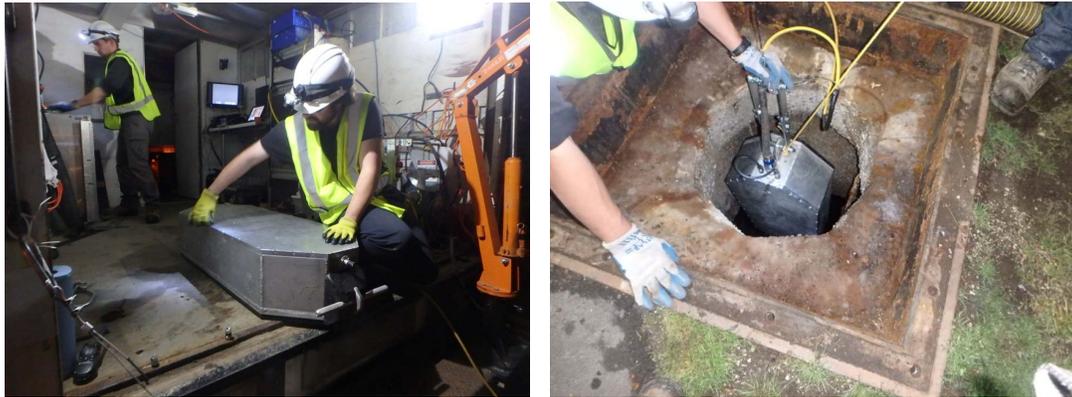
Figure 3. The dual frequency underwater PPR antenna before and during deployment.

In phase two of the project a dual frequency underwater PPR antenna was deployed to locate and measure any cracks at the invert of the pipe. Due to high

The dual frequency antennae operate on a 1 GHz and 250 MHz center frequency, thus obtaining both high resolution near surface data and deep penetration data in order to locate footings, columns and targets in the 1m to 5 m depth range. The 1 GHz antennae are ideally suited for mapping wall thickness, rebar cover, corrosion and any cracks and voids within and outside the pipe wall. Preliminary PPR results were not available at the paper submission deadline.

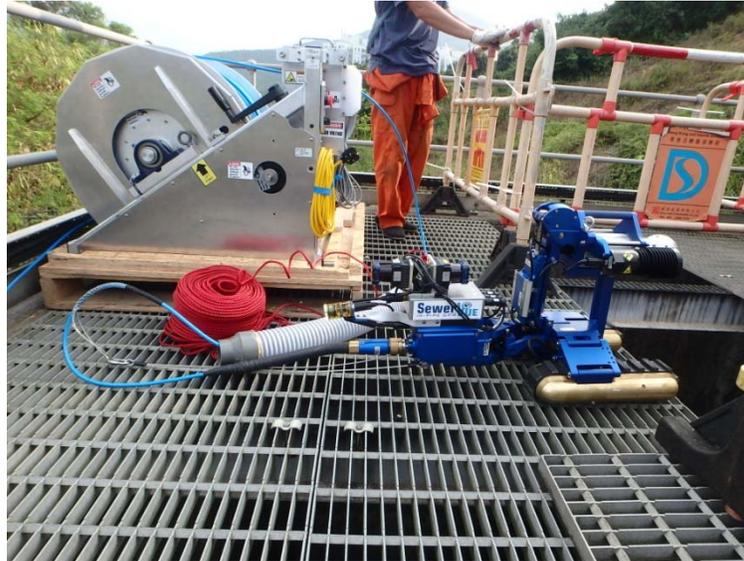
Figure 5. The multi-sensor inspection robot before deployment at Tolo Harbor, Hong Kong.

Due to the diameter of the pipe accurate dimensional information was critical for the condition assessment, since CCTV could only provide a supporting role. A modified multi-sensor robotic platform was used for the inspection. The long-range MPIS combines state of the art data collection and analysis with proprietary processing and reporting software. The tracked robotic inspection platform is outfitted with high definition CCTV and LIDAR sensors and has a 2000 m maximum deployment capability. LIDAR measurements determine the exact size and shape of the pipe and provide quantitative assessment of deformation and corrosion. The system is customizable and can be deployed through an 400 mm manhole and can be used to inspect any pipe size over 400 mm in diameter. Bypass pumping is not required as long as the camera is above the flow. Inspection reports provide integrated and quantitative corrosion and debris measurements, 180 degree virtual pan/tilt/zoom function, video, laser and sonar flats.

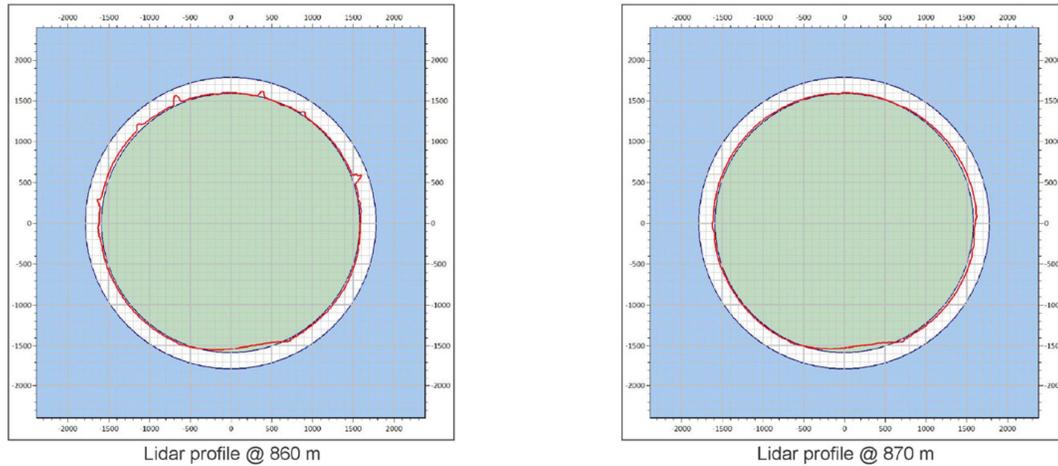
Figure 6. LiDAR Cross sections from the 3.180 m diameter Tolo Harbor, Hong Kong sewer tunnel.

structural defects, LiDAR cross sections at every 10 m interval, defects and observations from the CCTV and LiDAR and an interactive 4 in 1 viewer. Service and operational defects were mainly sediments (less than 5% cross sectional area), attached deposits, encrustations and other obstacles. The defect grades were 3 and 5 respectively. Structural defects were multiple cracks at joints (Grade 1), longitudinal fractures (Grade 3) and holes (Grade 4).
