**North American Society for Trenchless Technology (NASTT)
NASTT's 2016 No-Dig Show**

TA-T1-05

Quantitative pipe condition assessment with Pipe Penetrating Radar

Csaba Ékes, SewerVUE Technology Corp., 7993 Enterprise St., Burnaby, BC, Canada V5A 1V5; Tel: 1-888-973-9378, email: info@sewervue.com

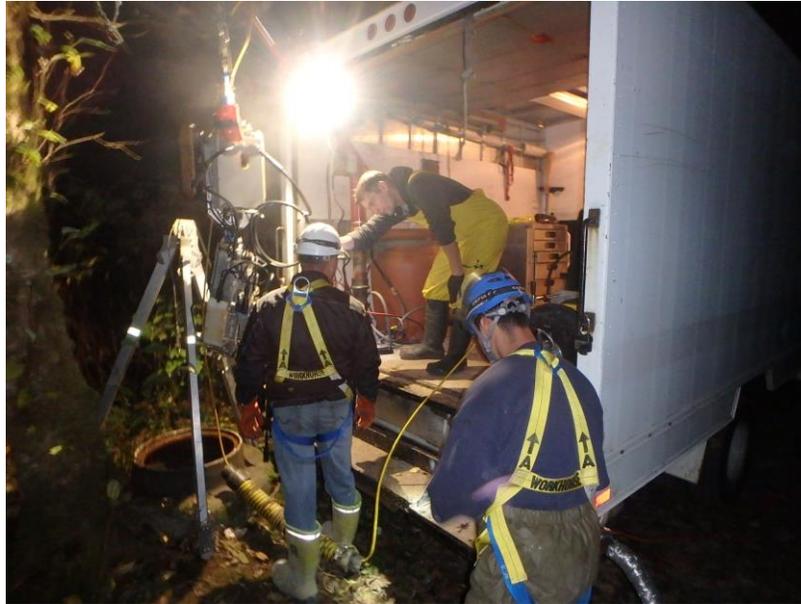
Figure 3. Technicians preparing for deployment of the SewerVUE Surveyor at the Bear Creek Trunk Sewer in Surrey, BC, Canada.

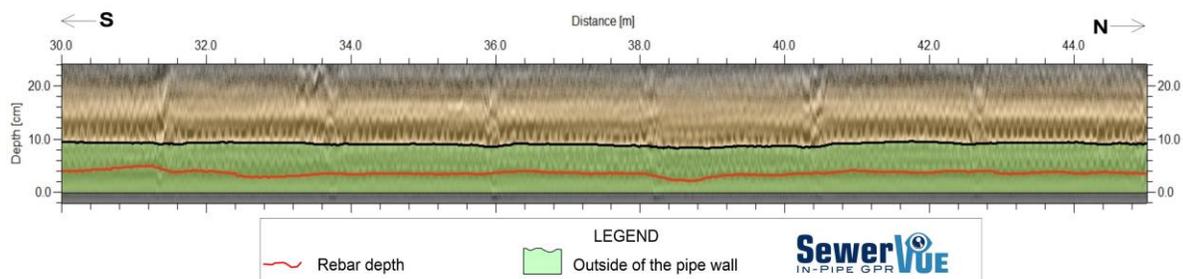
2D line data were collected on the crown of the pipe. The 2.3GHz antenna frequency provided good quality data and signal penetration to allow analysis to a depth of 20 to 30 centimeters from the inside pipe wall surface (Figure 4).

Figure 4. “Classic view” PPR results for the Bear Creek Interceptor, Surrey, BC.

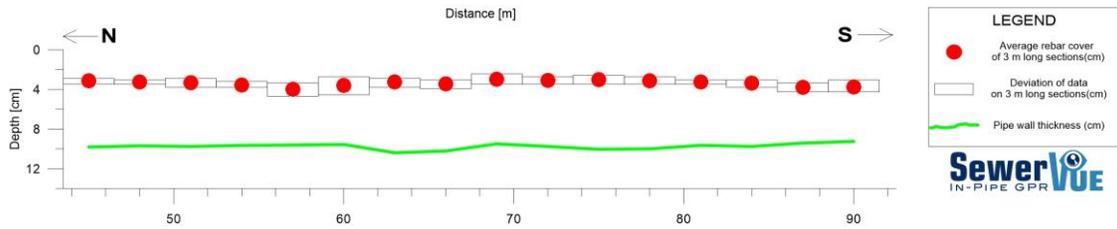
PPR inspection results are summarized on distance (meter) vs. pipe wall thickness and rebar cover (centimeters) graphs which are readily understood and are faster to review by lay audience (Figure 5). These summary graphs are based on data extracted from the processed and interpreted individual PPR depth sections. The distance shown on each profile is measured from the center of the manhole of deployment. Pipe wall thickness is represented by a continuous green line. Change in rebar cover is represented by bar graphs showing rebar cover variations (min-max) for every 3 m interval. Red dots mark average rebar cover for the same 3 m interval.

In Phase 1 of the project 388 m of PPR data were collected for the Bear Creek Trunk Sewer with the multi-sensor SewerVUE Surveyor inspection robot. Wall thickness was interpreted to be in the 80 to 100 mm range with little variation over the inspected length. Average rebar cover appears to be in the 3.5 – 5cm range with a few local higher deviations. There appears to be an anomaly between 54.7 and 55.6 m on Line 2 (Figure 4). The anomaly can be caused by possible ground disturbance or variations in the physical properties of the soil behind the pipe wall.

Figure 5. “Summary view” PPR results for the Bear Creek Interceptor, Surrey, BC Pipe wall thickness is represented by a continuous green line. Change in rebar cover is represented by bar graphs showing rebar cover variations (min-max) for every three metre interval. Red dots mark average rebar cover for the same three metre interval.

Preliminary results at the conclusion of Phase 1 concluded no significant structural issues on the inspected sections of the pipe.

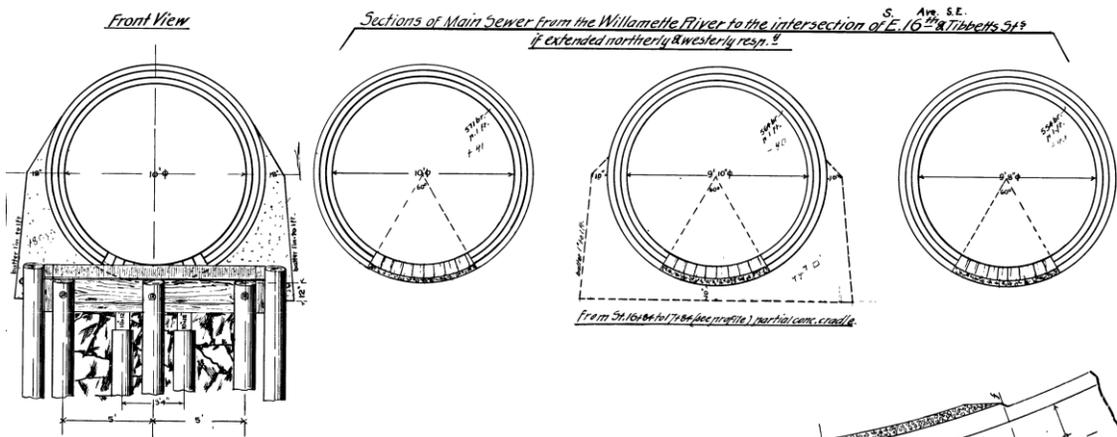
The second case study took place in a 120 inch diameter brick lined sewer that was originally constructed in 1906 (Figure 6). The Taggart Outfall is a combined sewer that, during intensive rainfall events, fills to capacity, and conveys flows to a deep tunnel system and can also convey wet weather overflows to receiving waters.

Figure 6. There was relatively little information available about the construction methods for the combined outfall.

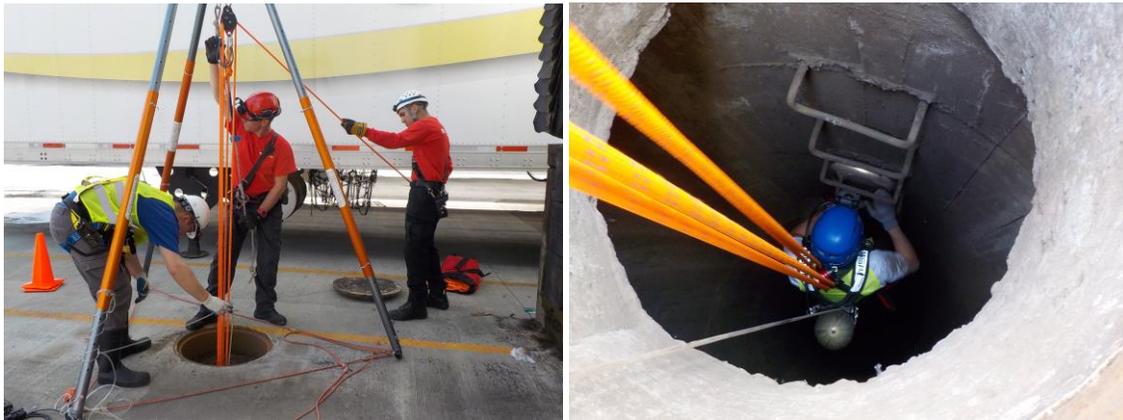
The inspection work was scheduled for the dry season for safety reasons and was completed in October 2014 (Figure 7). A total of 2040 feet were inspected via manned entry. The inspection was limited to pipe penetrating radar (PPR) data collection at the 12, 9 and 3 o'clock positions.

Figure 7. PPR technician and emergency rescue team supervisor preparing for the manned entry survey.

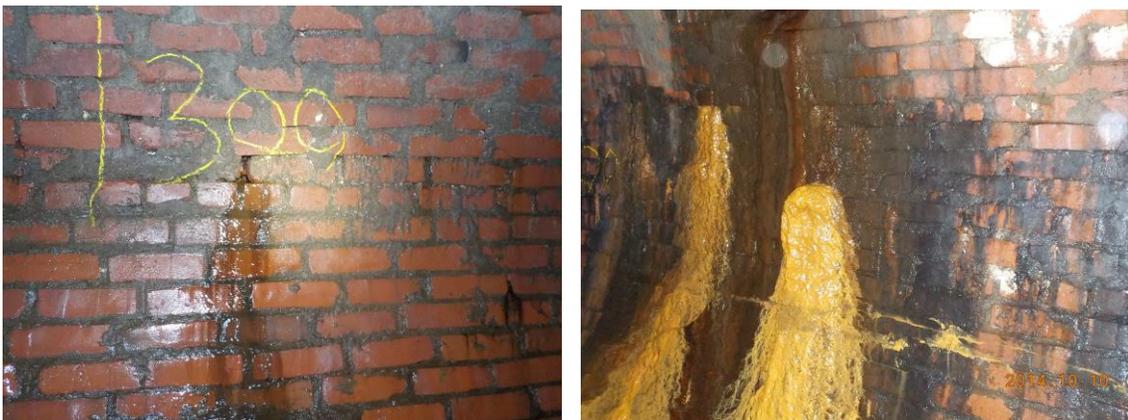
The PPR antenna was placed on a custom made extension arm to ensure good antenna/pipe wall coupling. Since the 12 o'clock position was the most critical these lines were surveyed twice, generally in 50 ft increments. The 3 and 9 o'clock positions were surveyed once in 100 ft long sections. At the end of every (50 or 100 ft) line the data were saved and the file name was recorded. Observations during the survey were recorded in order to aid data interpretation (Figure 8).

Figure 8. Visual observations such as infiltration or clay deposition were recorded during the inspection. Most of the pipe visually appeared to be in a good condition.

Visible features such as laterals, infiltration, clay and Calcite deposits were noted (Figure 8) during the inspection. These notes were compared with the processed and interpreted PPR profiles. No direct correlation was found between the observed features and the interpreted profiles. This finding is significant and shows that “what you see is not what you get”, i.e. visible anomalies don’t accurately reflect the condition of the pipe.

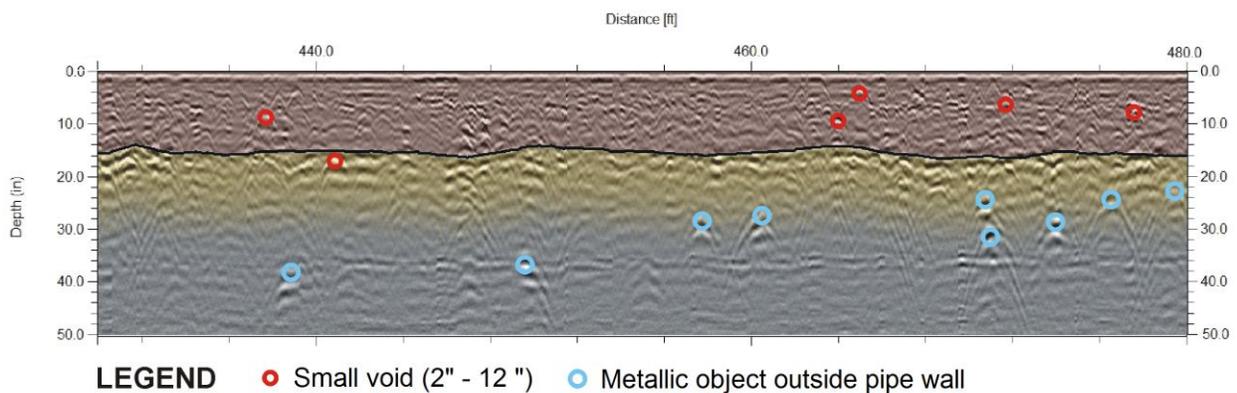
The PPR profiles have a depth scale in inches on the vertical axis, corresponding to about a 50 inches total depth of investigation (Figure 9). All the collected PPR data are of high quality and rich in detail.

The interpretation was based on the careful analysis of certain reflections that show the expected brick liner/fill interface in all of the depth slices in all directions. A given reflection was compared to the surrounding signal strength. A processed and interpreted depth profile is shown in Figure 9.

The primary objective of the inspection was to identify voids larger than two inches in diameter outside the three courses of bricks. Voids were characterized according to size: 2-12 inches, 12-36 inches and >36 inches. No voids larger than 36 inches in size have been identified. In addition to identifying void type anomalies, other anomalies were also marked and interpreted. These include: non-void type anomalies outside the pipe, which were interpreted as metallic and wood objects. Voids and possible damage zone within the three courses of bricks were identified together with the interpreted brick + mortar and fill interface.

Figure 9. Interpreted PPR profile from a 120 inch diameter brick lined sewer.

The interpreted anomalies were recorded on the processed PPR profiles and cross referenced with clock position and survey distance features. Areas of void type reflections are sometimes seen along the liner-fill interface (Figure 9). These zones are conspicuous by their pronounced irregular “bright spot” anomalies with higher amplitude and lower frequency (i.e. wider banding) relative to their surroundings. Void type anomalies were divided into three groups: small voids (2 -12 inch) medium voids (1 -3 feet) and voids larger than 3 feet. No voids larger than 3 feet were identified on any of the surveyed lines. The results are summarized and tabulated according to void size and location within the pipe (Table 1).

The three courses of bricks can be identified on some of the profiles some of the time (Figure 9). Well defined hyperbolic arches within the three courses of bricks were interpreted as small voids (Figure 9). Concentrated hyperbolic arch pattern indicate reflections and scattering from sides of individual bricks. This pattern may indicate missing mortar and these were identified as possible damaged zones.

A total 2040 ft of the sewer was surveyed with a hand held 1 GHz frequency PPR system. Signal penetration was between 20 to 40 inch depth, the data are of high quality. The most prominent feature on all the profiles is the pattern change often accompanied with a near horizontal, wavy interface at 16 ± 4 inch. This feature was interpreted as the brick liner/backfill interface (Figure 9). The observed anomalies were grouped into three categories in relation to this interface:
