**North American Society for Trenchless Technology (NASTT)
NASTT's 2016 No-Dig Show**

TA-T1-05

Quantitative pipe condition assessment with Pipe Penetrating Radar

Csaba Ékes, SewerVUE Technology Corp., 7993 Enterprise St., Burnaby, BC, Canada V5A 1V5; Tel: 1-888-973-9378, email: info@sewervue.com

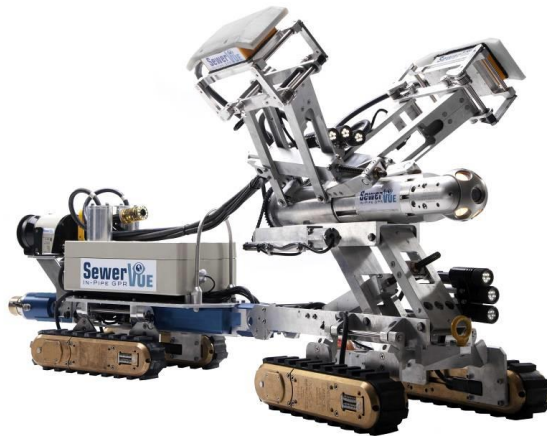
Figure 2. The fourth generation SewerVUE Surveyor multi sensor inspection robot equipped with HD pan tilt zoom CCTV, PPR and LIDAR.

The SewerVUE Surveyor is the first commercially available multi sensor inspection (MSI) robot that uses visual and quantitative technologies (CCTV, LIDAR, and PPR) to inspect underground pipes (Figure 2). This fourth generation PPR pipe inspection system is mounted on a rubber tracked robot and equipped with two high-frequency PPR antennae. The system used in Surrey, BC, Canada can be adjusted for 21 to 60-inch diameter pipes, the PPR antennae can be rotated between the nine and three o’clock positions. Radar data collection is obtained via two independent channels in both in and out directions, providing a continuous reading on pipe wall thickness and locating voids outside the pipe. CCTV data is recorded simultaneously and is used for correlation with PPR data collection.

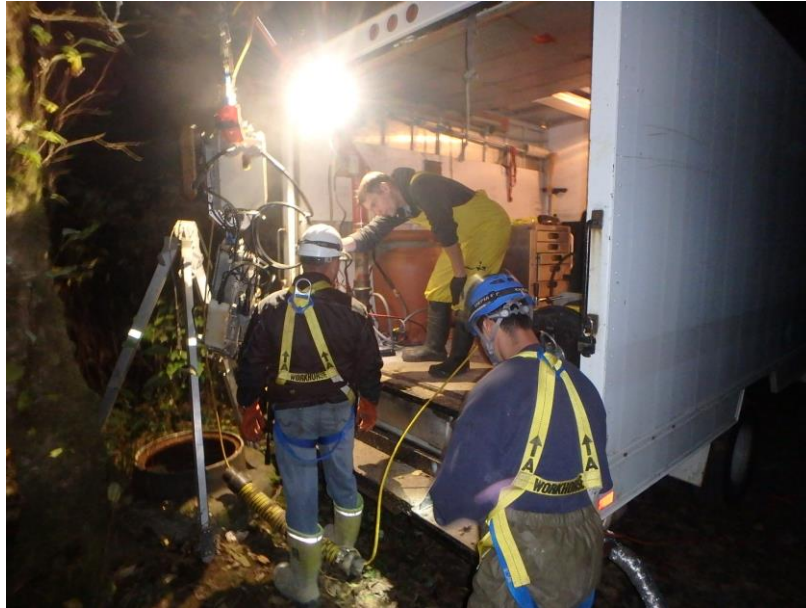
Figure 3. Technicians preparing for deployment of the SewerVUE Surveyor at the Bear Creek Trunk Sewer in Surrey, BC, Canada.

This project’s PPR survey was completed using 2.3 GHz frequency antennae while the pipe remained in service. Narrow manhole frames, offset manholes and high flow conditions created deployment challenges. Most of the work was completed during night shifts.

In Phase 1 of the project 388 m of PPR data were collected for the Bear Creek Trunk Sewer with the multi-sensor SewerVUE Surveyor inspection robot. Wall thickness was interpreted to be in the 80 to 100 mm range with little variation over the inspected length. Average rebar cover appears to be in the 3.5 – 5cm range with a few local higher deviations. There appears to be an anomaly between 54.7 and 55.6 m on Line 2 (Figure 4). The anomaly can be caused by possible ground disturbance or variations in the physical properties of the soil behind the pipe wall.

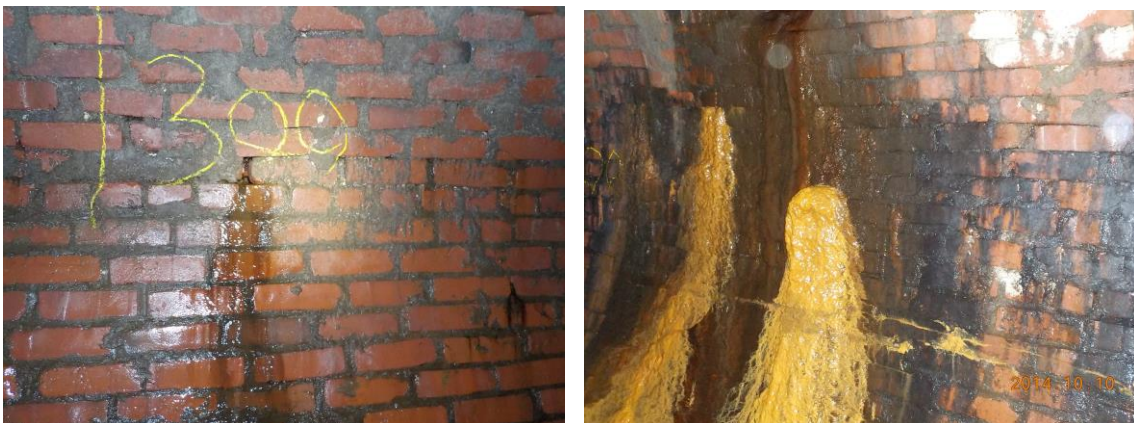
Figure 8. Visual observations such as infiltration or clay deposition were recorded during the inspection. Most of the pipe visually appeared to be in a good condition.

The PPR antenna was placed on a custom made extension arm to ensure good antenna/pipe wall coupling. Since the 12 o'clock position was the most critical these lines were surveyed twice, generally in 50 ft increments. The 3 and 9 o'clock positions were surveyed once in 100 ft long sections. At the end of every (50 or 100 ft) line the data were saved and the file name was recorded. Observations during the survey were recorded in order to aid data interpretation (Figure 8).

Visible features such as laterals, infiltration, clay and Calcite deposits were noted (Figure 8) during the inspection. These notes were compared with the processed and interpreted PPR profiles. No direct correlation was found between the observed features and the interpreted profiles. This finding is significant and shows that “what you see is not what you get”, i.e. visible anomalies don’t accurately reflect the condition of the pipe.
