**Sanitary Sewer Pipe Inspection  
Pipe Penetrating Radar  
Salmon Creek and St John's Trunks  
Vancouver, WA**

September, 2012

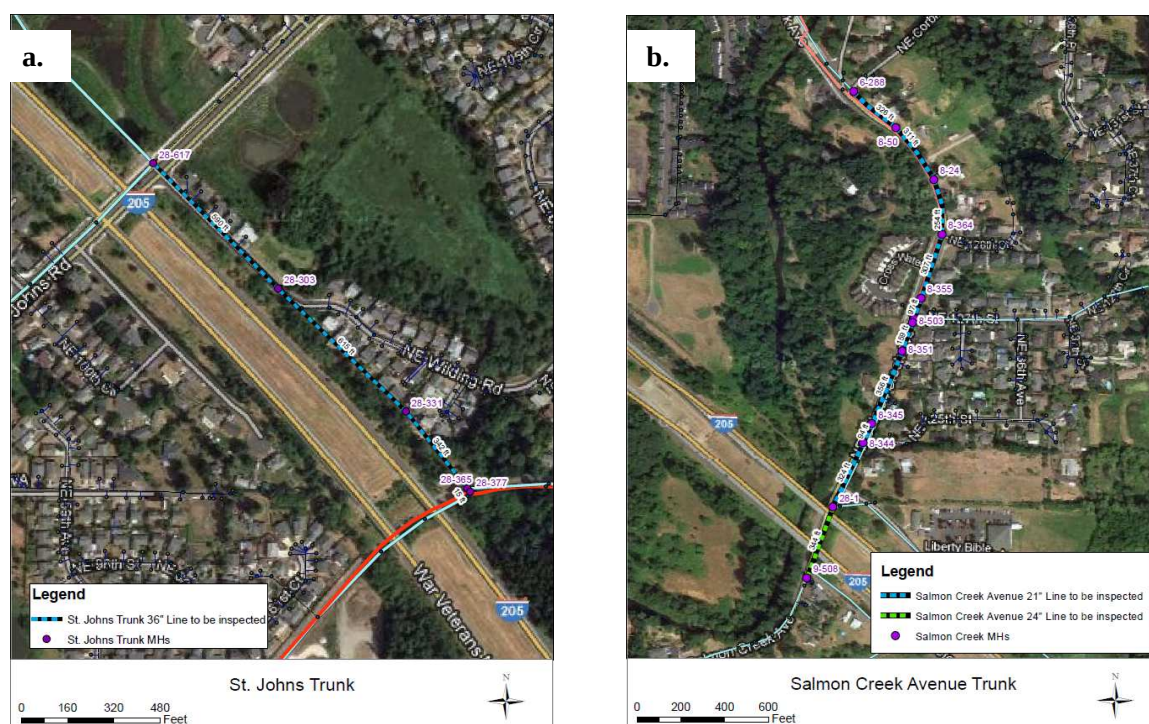
**Figure 1.** The inspection area at St. Johns Trunk (a.), and at Salmon Creek Avenue Trunk (b.) Vancouver, WA.

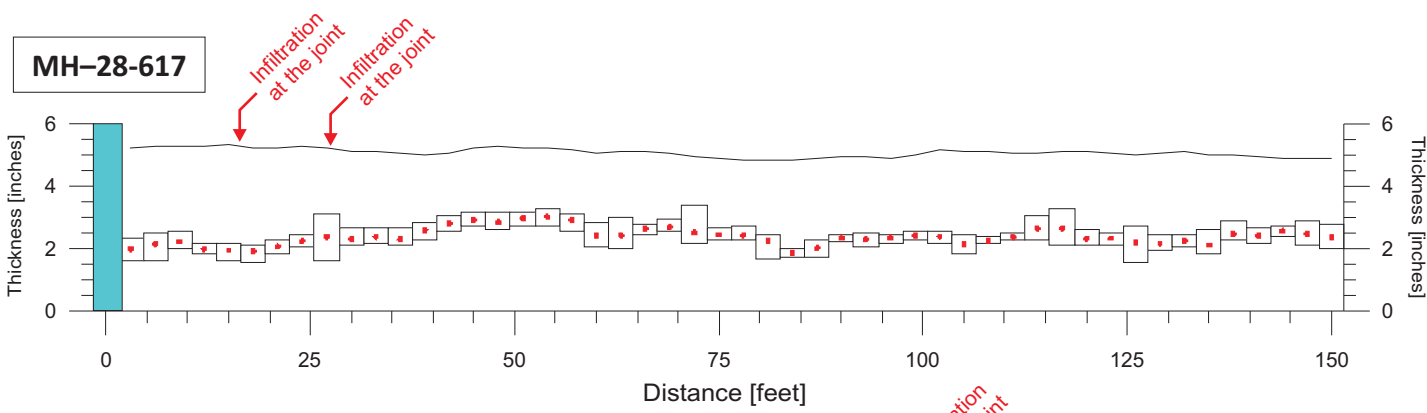
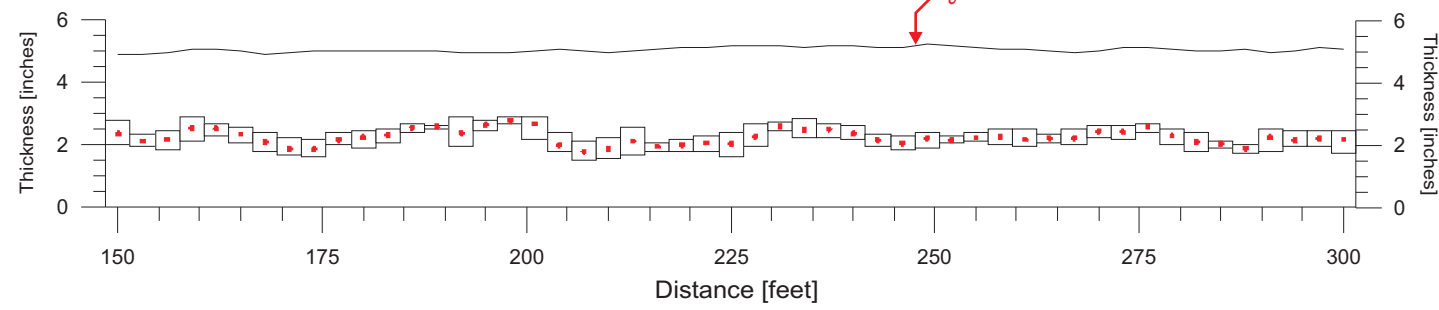
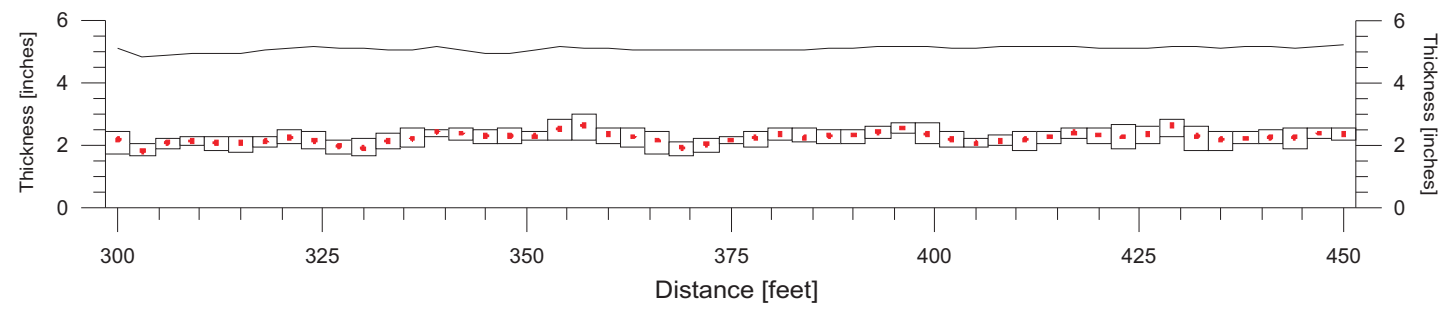
The PPR data indicate variations in pipe wall thickness, as well as location, depth and spacing of rebar. The results show that pipe wall thickness is around 5 and 5.25 inches, between 0 and 1085 ft. It is between 5 and 4.5 inches between 1085 and 1460 ft, and between 4.5 and 3.75 inches between 1460 ft and 1545 ft at the upstream manhole MH 28-377 where corrosion appears most severe.

Rebar cover varies between 1 and 4 inch. Rebar signal is weak between 1475 and 1505 feet and very weak or appears to be absent between 1505 and 1545 feet. A minor void was detected at 27.5 ft at 10 o'clock position. This void is approximately 4 feet long and 4 inches high.

Overall, the majority of the 36-inch trunk line is structurally in fair to poor condition. Inspection of the upstream-most pipe segment revealed evidence of severe corrosion. The PPR data indicated less concrete rebar cover at the upstream section of the trunk line and a loss of wall thickness as the robot moved upstream. Assuming the initial pipe design considered the railroad loading and appropriate dead loads, the loss of wall thickness and suspected corrosion in the reinforcement indicates that the existing pipe may be compromised structurally.

The use of PPR combined with man-entry coring and visual CCTV data provided the necessary information for the District to understand the condition of these critical trunk lines. For the St. Johns Trunk, the lack of rebar signal and the concrete material scraped off during the PPR inspections indicate poor structural condition. This condition can be addressed trenchlessly before further deterioration renders a trenchless solution infeasible. For the Salmon Creek Interceptor, knowing that the 21-inch portion does not contain reinforcement is important information. Follow-up man-entry inspections confirmed that the pipe is in poor to fair condition; rehabilitation, while not immediately urgent, should be planned for in the near future.
